## Volvo Electrical: Instrument Panel Repair

### [Volvo Maintenance FAQ for 7xx/9xx/90 Cars](#)

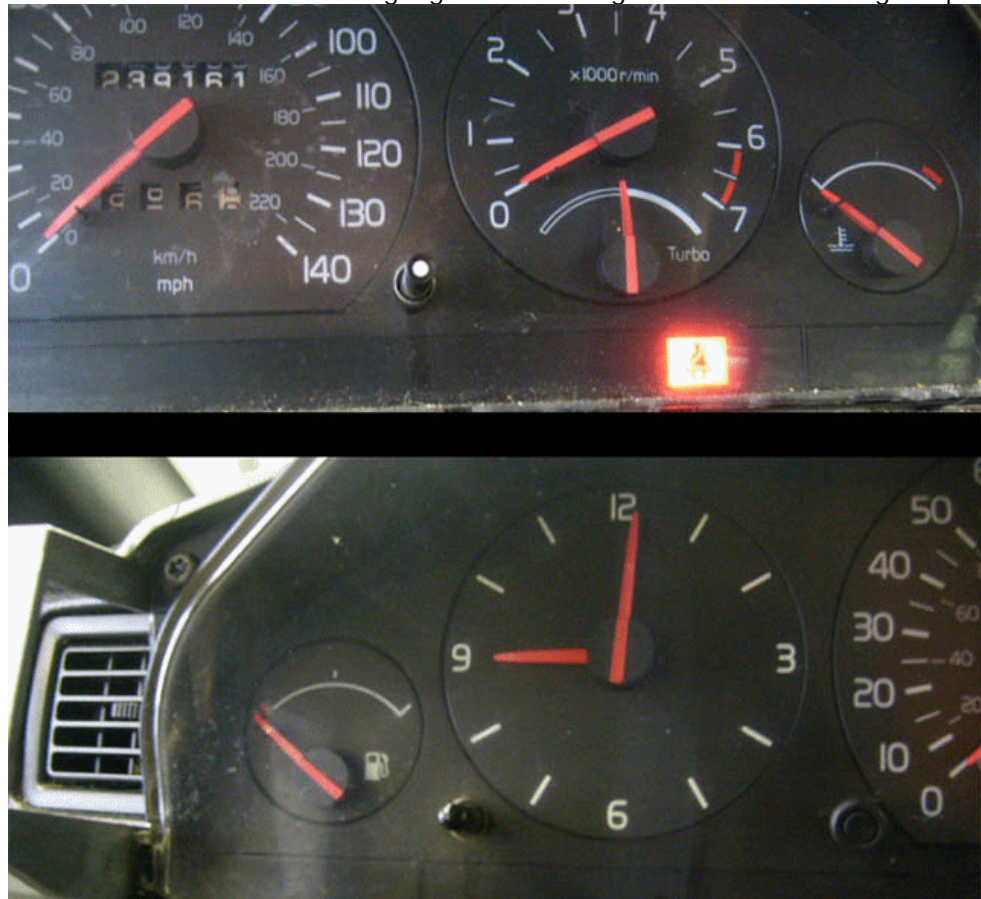
Here is the cluster showing symptoms before removal. The fuel gauge does not register and the warning lamps do not light,

except for the seat belt reminder.

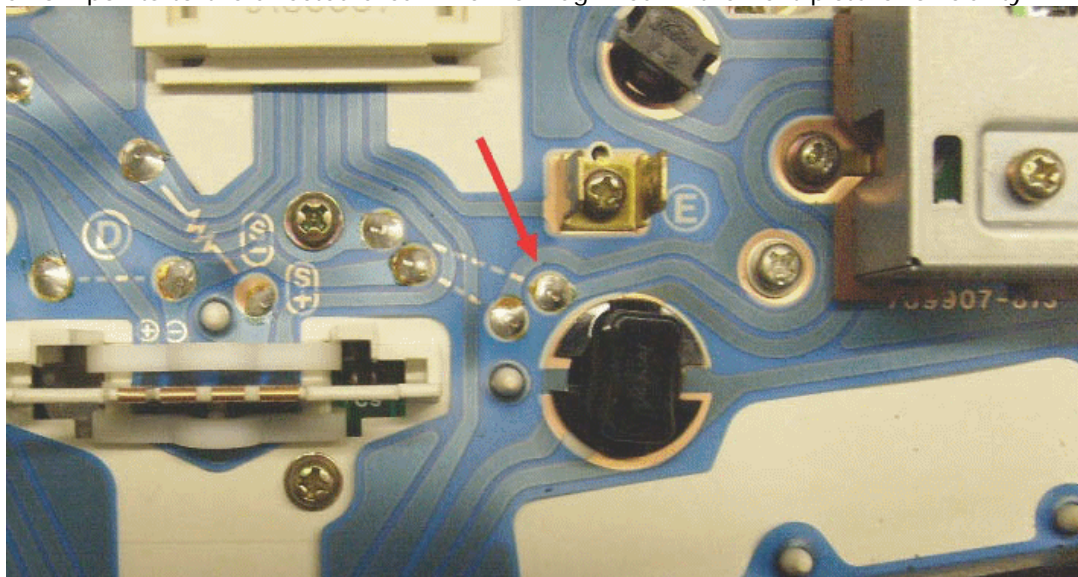
To remove the cluster, pop the metal trim around it out and remove the two screws securing the frame with the cluster in it. The frame and cluster can be removed together and with some careful handwork it will come out. Disconnect all of the connectors from the rear carefully and note which connector belongs in each position. Once the cluster is removed this is what you will see on the rear of it. A printed circuit board with numerous distribution strips and solder joints is present. The arrow points to the affected area which is magnified in the next picture for clarity.

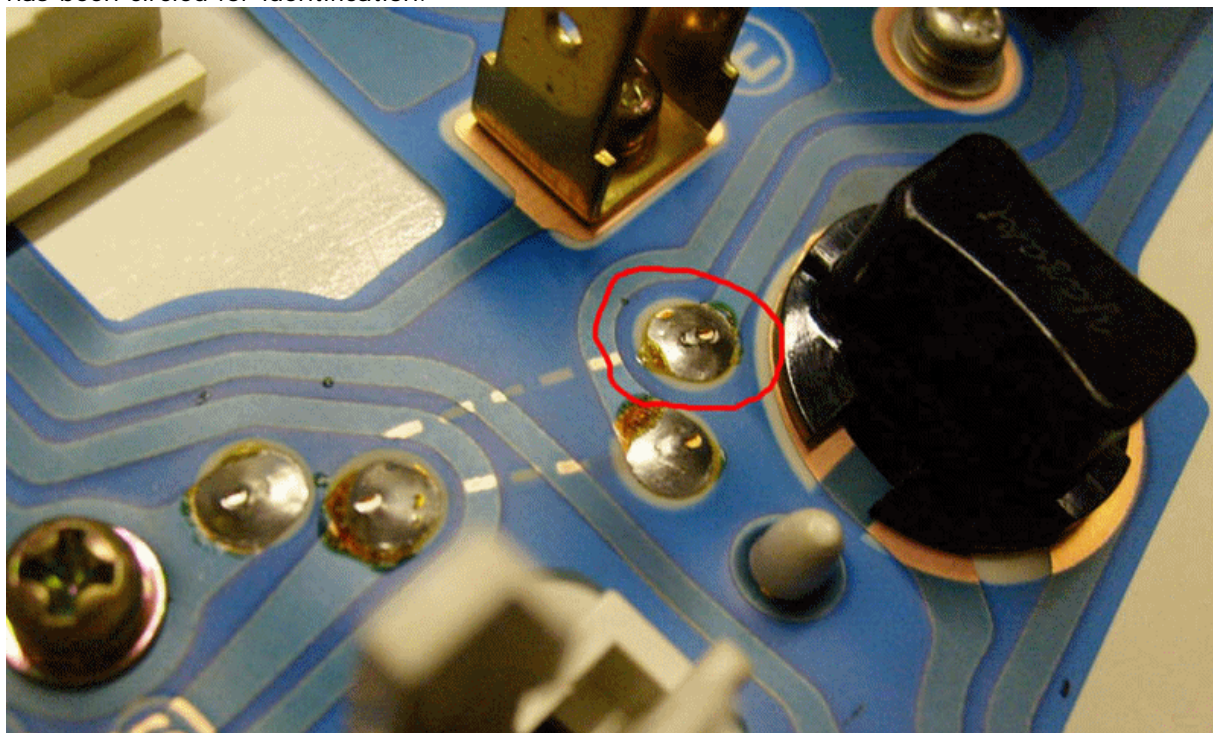
If you have good eyes you may not need one but I recommend a magnifying glass to inspect the solder joints. You are looking for joints that have a break in the solder that prevents a connection from being made on the circuit board. These breaks occur from heat soak and poor solder composition as well as just plain age of components. When I removed the cluster from the 940 and examined it closely, it did not take long to identify the culprit. Here in this picture, the bad joint has been circled for identification.

What needs to be done is simple. Go around the board and reflow a small amount of fresh solder over each of the joints. There are also a few solder joints on the bottom of the circuit board so make sure to get them as well. A pencil soldering iron is all you need and can be had at Radio Shack for about \$12, solder is available there as well. Wait for the soldering iron to pre-heat and then touch it lightly up to a joint while lightly touching a bit of new solder to the tip of the gun. Wait for the solder to cleanly flow over the entire joint and make a clean connection. Be careful not to bridge (let the solder expand to another joint, creating a short) any joints. You also do not want to leave a cold solder joint which is an area that is not fully heated to allow the solder to completely flow over the connection. Cold solder joints create resistance and sometimes don't make a connection at all, they also do not last as long if they work at all. After soldering all of the joints, carefully examine your work to make sure all the new solder has flowed over the joints in a clean fashion and that none of

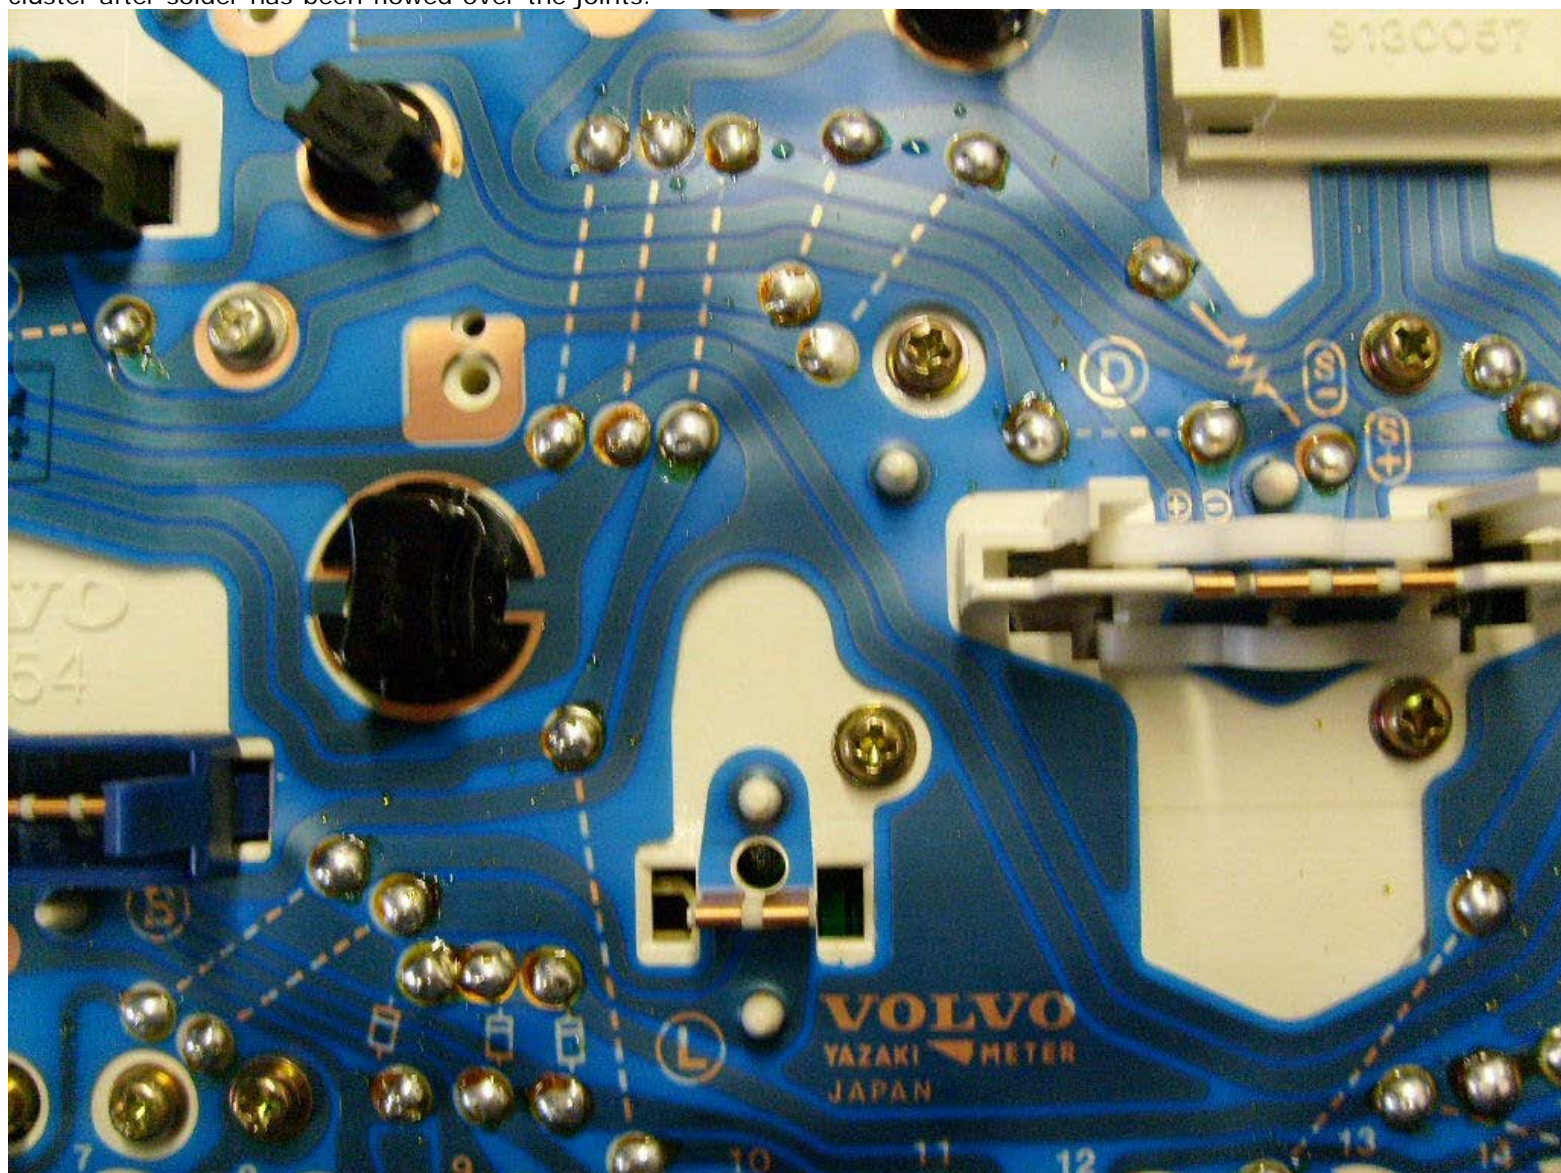
it has bridged over to any other joints that it was not supposed to. Take a picture beforehand for your own reference if you would like to see what it looked like before any repairs. This picture here shows a semi-close view of the rear part of the cluster after solder has been flowed over the joints.

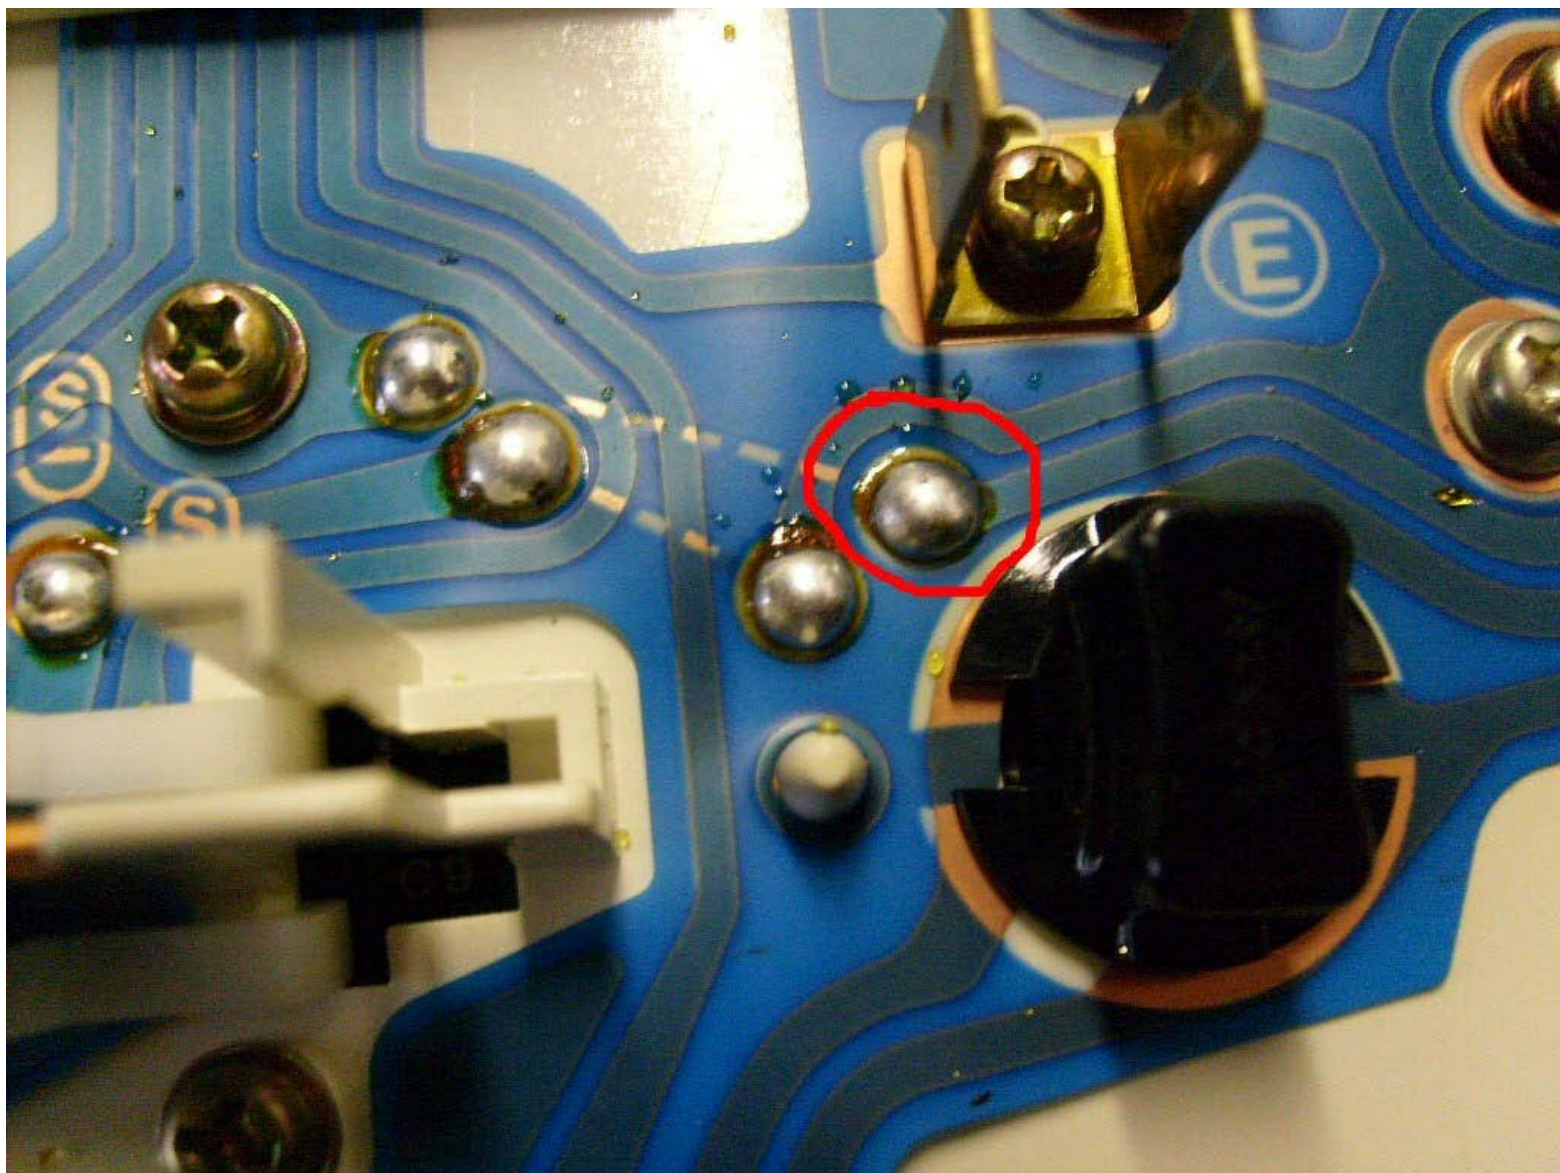
Here is the picture of the previously broken solder joint after repairs. Again, a closer view and circled for identification.

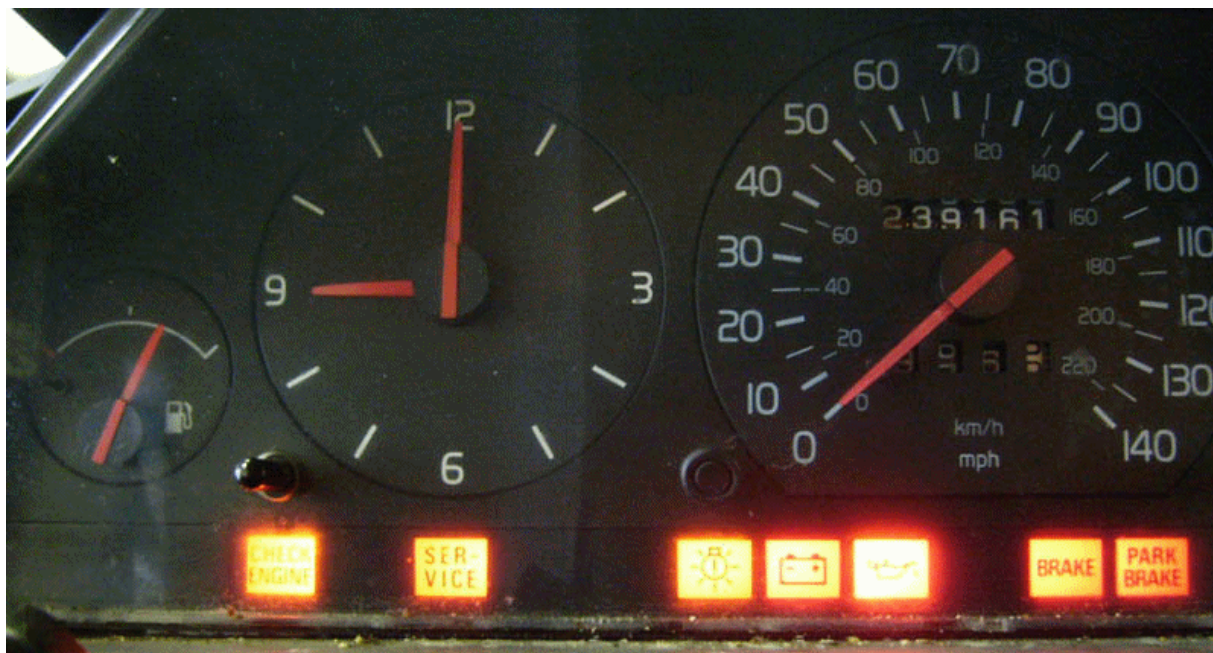
So now that the repair is complete, time to test the cluster. I reinstalled the cluster and connected all of the connectors but did not screw it down in case something didn't function or wasn't connected fully. EPIC WIN! All of the cluster warning lights work and BAM gas gauge works! Sweet, I am happy, the customer is ecstatic and if you do this, you will be happy too.

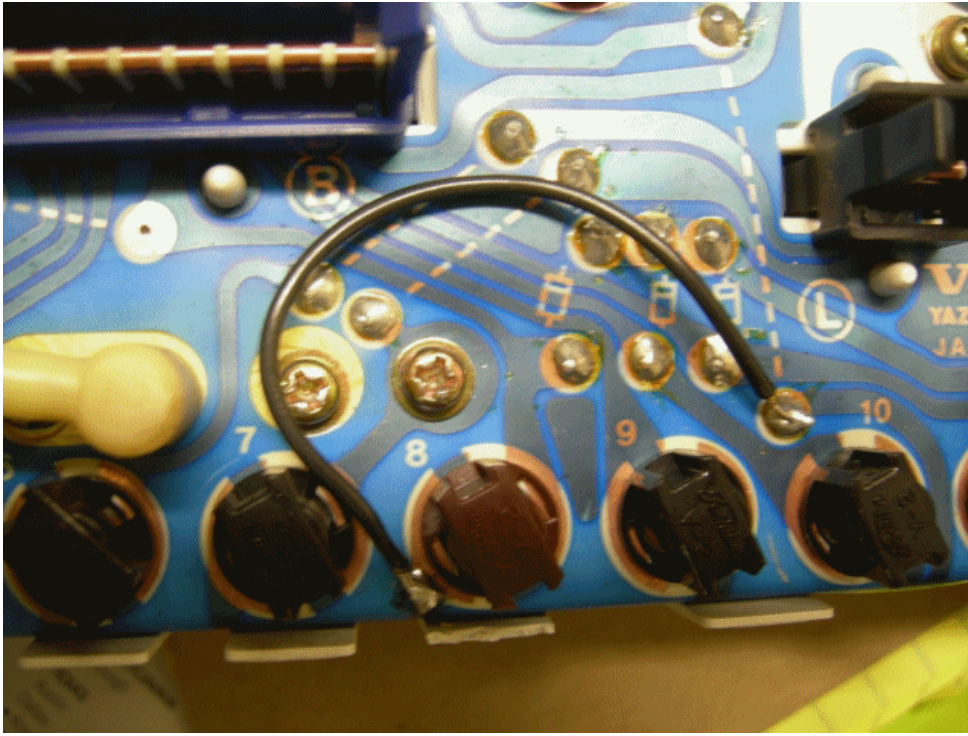
Volvo 940 and 960 instrument clusters suffer from printed circuit foil and solder joint troubles. I've had trouble with the ABS and Coolant Loss warning lights not working. The problem has been a break in the printed circuit track feeding those two warning lights. If your ABS or Coolant Loss light don't come on with the engine off and key in the run position, your car has this problem. 940s didn't come with a Coolant Loss warning light, but many of us have added them using the 960 Coolant Reservoir. Sometimes the Parking Brake warning light doesn't work in addition. The picture below shows three warning lights on the back of the cluster. Light 8 is for Coolant Loss, light 9 is for ABS, and light 10 is for the Parking Brake. The problem is the printed circuit track feeding lights 8 and 9 from light 10 will have a defect and not supply electricity. Installing a jumper wire from the solder joint just above lamp 10 to the printed circuit board a lamp 8 fixes the problem. It beats buying another instrument cluster that may have the same problem.

For some reason, it is warning lamps 8 and 9 that give trouble, and sometimes warning lamp 10 (which would probably include lamps 11 and 18, see below). The Emergency Brake warning light was occasional along with warning lamps 8 and 9, when I bought the car. The speedometer was bad and I bought a used instrument cluster with a good speedometer. The used instrument cluster had no power to lamps 8 and 9, and the spare cluster I just bought had the same problem. Any one with a 900 series should check to see that all of the warning lamps, shown in the owner's manual, are functional.

The same track feeds warning lamp 11, BRAKE, and lamp 18, SERVICE. So those lamps may also fail depending on where the break is. I can install jumpers to all of them to save a car.

Carefully scrape the plastic off of the foil to make it bright. I use a 25 watt iron with a chisel tip to quickly tin the foil. You must move fast and very quickly melt the solder onto the foil, or you'll curl the plastic base. I use electronic solder with resin flux which contains lead. The solder with lead in it works the best for me. I understand it is hard to get.

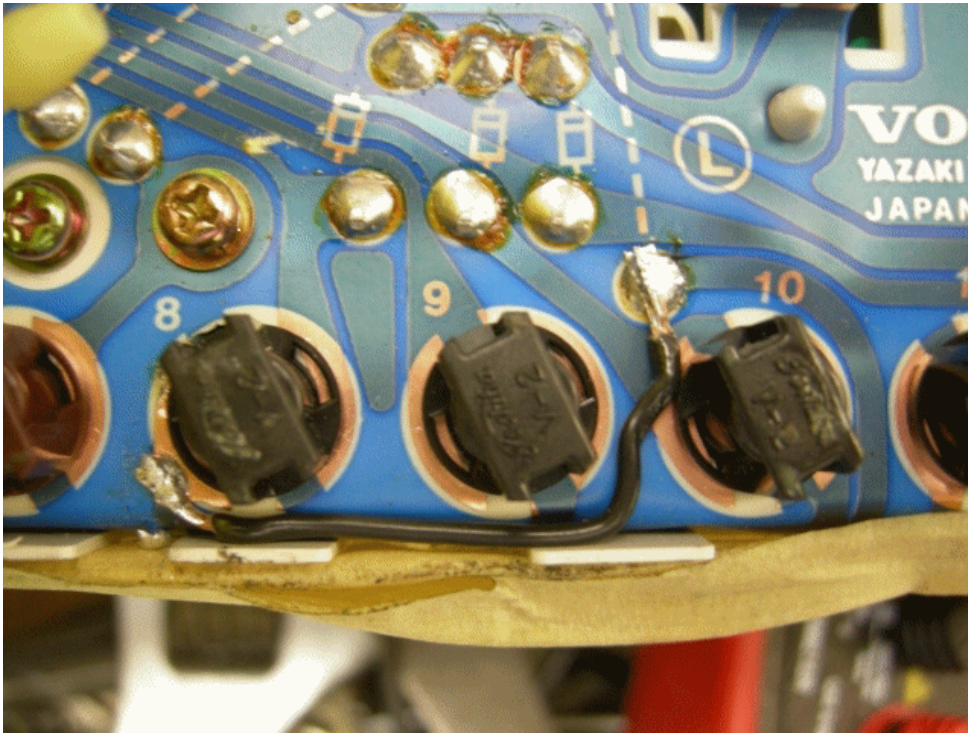
The picture below shows another instrument cluster with a slightly different repair.

I've seen three of these failures.
