Volvo Plastic Fuel Tank Repair

Emergency Plastic Fuel Tank Repair

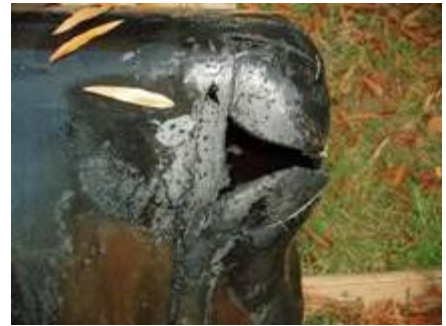
[Will Dallas] In the event of a punctured polypropylene fuel tank like is found on the 700/900 series Volvos, I have come up with a way to effectively and permanently patch the hole with a few simple tools. The tank that I am using for demonstration is one that had holes cut into it purposely so the vehicle could be scrapped. It is out of an 88 780 Bertone and will be reinstalled after a leak check.
