Service Bulletin.

TIMING GEARS

B16A, B16B

Oil grooves in camshaft gear guide flange

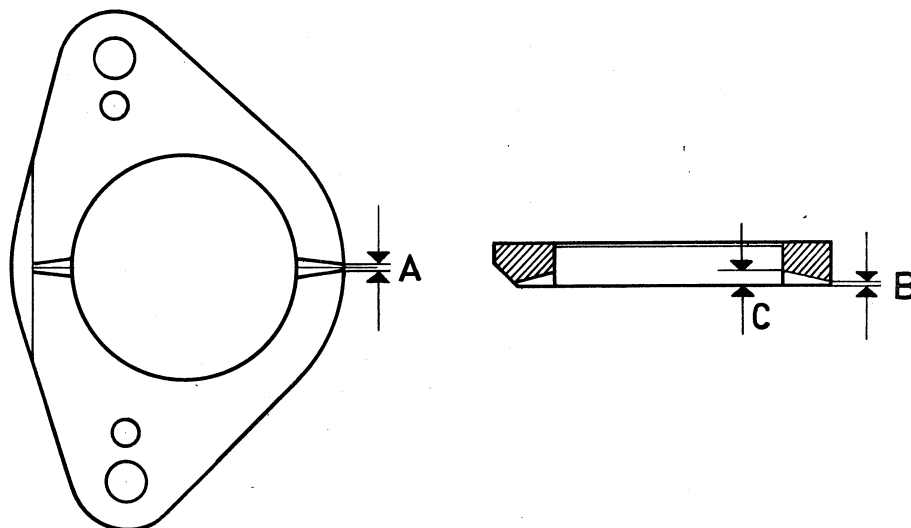
An increase in wear of the camshaft gear has been noticed lately. On examination it has been found that this can possibly be due to inadequate oil supply and we have therefore reintroduced oil grooves in the camshaft axial guide flange. Flanges with grooves have part number 403182 and without grooves, 403998.

When this has been done, oil pressure at idling speed will fall by about 1.4 p.s.i. (0.1 kg/cm^2) but this is of no practical significance. Note that the grooves must not be made deeper or wider than shown in the sketch as otherwise the oil flow through the grooves will be excessive.

When replacing camshaft gears on engines not having oil grooves in the steering flange, the latter should be replaced by flanges with grooves but it is also possible to file out grooves in the old flange. Use a three-square file (60° angle).

A = Width at outer edge, max. 0.04" (1 mm)

B = Depth at outer edge, 0.012 ± 0.004 " (0.3 ± 0.1 mm)

C = Depth at inner edge, 0.12" (3.0 mm)
