Service Bulletin.

Noise in throttle control

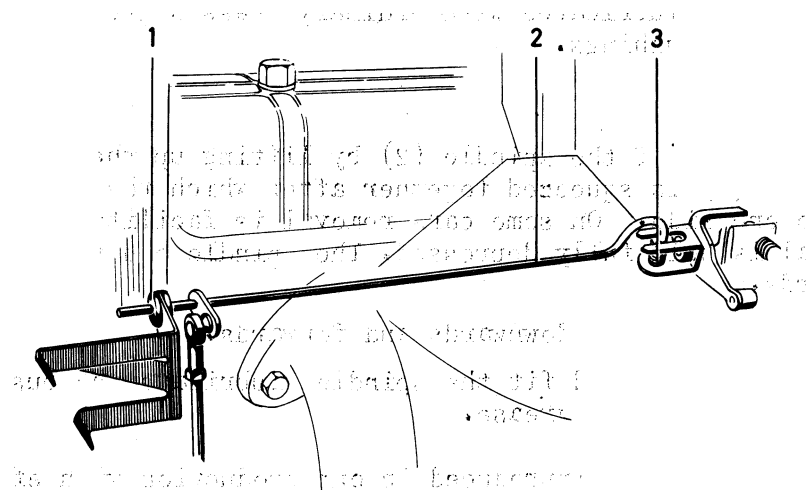
Two types of bushing, nylon and rubber respectively, have previously been used as a support for the upper spindle. In certain cases, unfortunately, these bushings have been the cause of a squeaking noise.

We have now modified the mounting so that only one type of bushing (of Vulcollan), part number 658660, is used. See figure overleaf.

In the event of complaints arising concerning squeaks in the old type bushings, these can be lubricated with ordinary chassis grease but the best way is to fit the new bushings.

1. Remove the front end of the spindle (2) by lifting up the bent-over part so that the spring (3) is squeezed together after which the spindle is moved backwards and to one side. On some cars removal is facilitated if the accelerator pedal is held fully depressed. The spindle can then be moved further backwards.
2. Pull the spindle obliquely downwards and forwards.
3. Replace the bushing (1) and fit the spindle. Lubricate the bushing lightly with ordinary chassis grease.
