Service Bulletin.

Re: Noisiness in Spicer rear axle

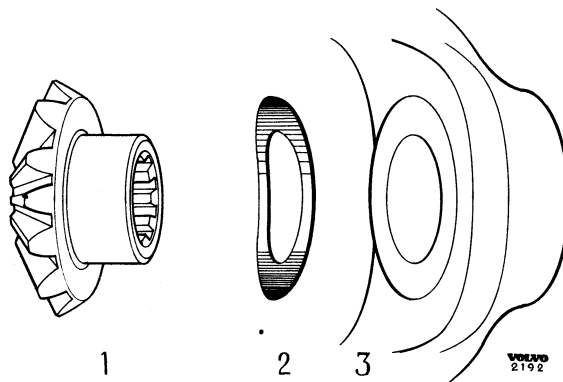
1. Differential gear
2. Thrust washer, part number 658620
3. Differential carrier.

Should any rear axle noise develop on the above mentioned cars fitted with Spicer rear axles (see Illustration II in the Service Manual, PV 444-445, Part 5, Rear Axle), carry out an examination to see if the noise is emanating from the differential side gear or the differential pinion gear (33, 36). Should this be the case, we recommend you to replace the plain thrust washers (34), part number 120620 with spring thrust washers, part number 658620.

1. Remove the wheels, hubs and brake backing plates, then pull out the axle shafts (11) until they are clear of the differential side gears (33).
2. Remove the cover (42). Turn the differential carrier, drive out the lock pin (27) and the pinion shaft (28). Remove the spacer block (29), differential gears and thrust washers.
3. Check that the recessed thrust washers (37) are in good condition. Replace them if they are worn. Fit the spring thrust washers so that the "back" of the washers is towards the differential carrier, see the illustration. Fit the other components.
4. Check that the end play of the rear axle shafts lies within the limits 0.003 - 0.008" (0.07 - 0.20 mm).
5. Check the finish on the spaceblock and the end of the drive shafts as outlined in Service Bulletin Group 50, No. A20.
