Service Bulletin.

BONNET LOCK

Amazon

Re: Adjusting bonnet lock

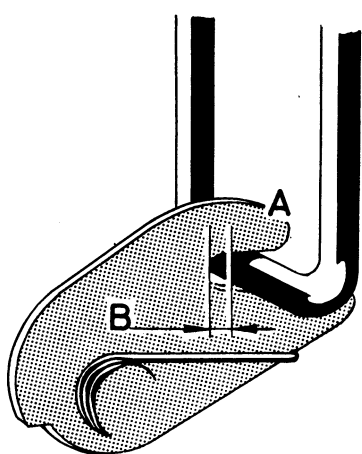
FIG. 1

The reason for involuntary releasing of the bonnet is usually due to stiffness in the pulling device which prevents the handle and therefore also the locking catch from returning to normal (locked) position.

When the bonnet is locked the hasps should be completely inside the slot in the catch as shown in fig 1. The measurement B in the figure may be max 3 mm (.12") otherwise there is a risk that the hasp may get shaken over the lip at A. Any necessary adjustment should be carried out on the hasp.

B = max. 3 mm.

In order to carry out this check one of the grilles should be removed.

The hasp should be adjusted vertically so that the gap between the bonnet and the front part of the body is 4.5 ± 1 mm (.18 \pm .04").

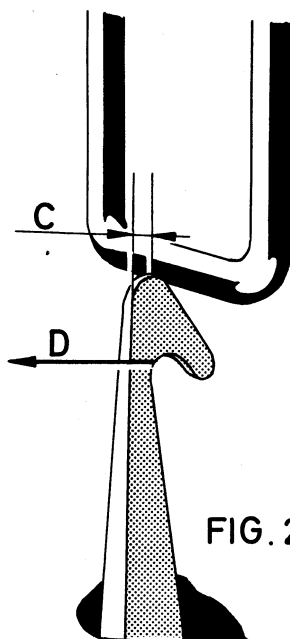
FIG. 2

- A First check that the tension of the safety catch spring is sufficient. A pull of min 0.1 kp (.22 lb) at the top of the catch (see fig 2) should be necessary before it can be moved from the locked position.
- B Then check that when the bonnet is closed, the hasp meets the safety catch as near to the top as possible without the lip being deflected forwards out of the way. See fig 2.

C = 2-3 mm.

D = min 0,1 kp

A minor adjustment of 1 - 2 mm (.04 - .08") can be done by bending the

safety catch. If any greater adjustment should be found to be necessary this means that the whole locking device has become displaced. In this case the whole bonnet lock should be readjusted.
