VOLVO

Service Bulletin.

FRONT SEATS

Re: Seat catches

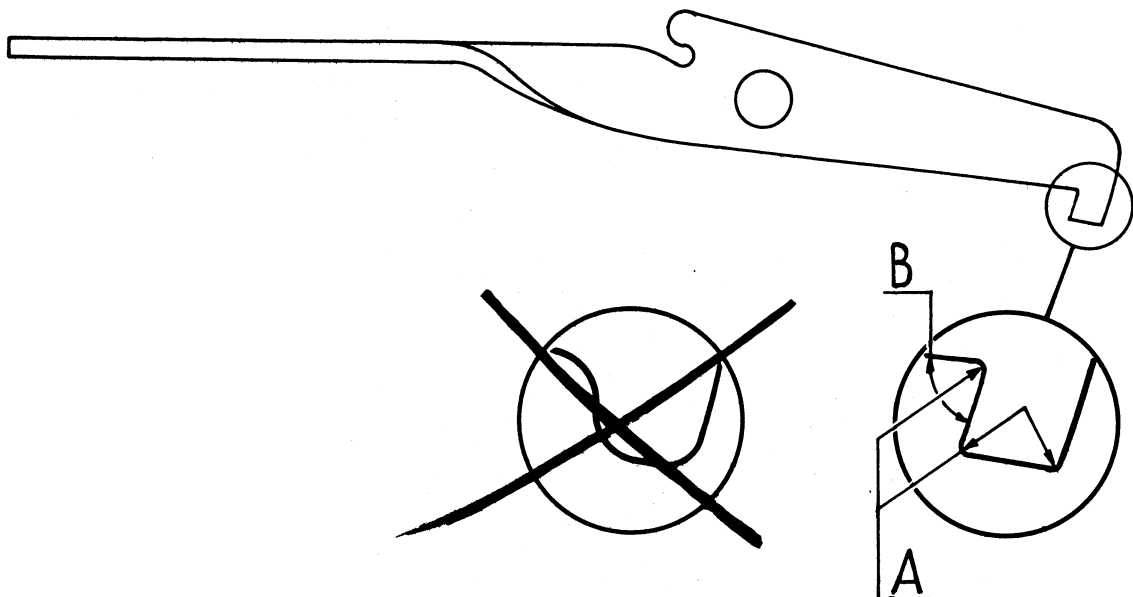
There have been some complaints that the catches for the front seats do not lock properly.

Examination has shown that during machining, the catches may have received such large radii (see the crossed out figure) that they can slide out of position when loaded.

In cases of complaint the catch should be filed out as shown in the figure. The radii (A) on the catch arm must be maximum 0.04 " (1 mm). The angle (B) between the catch arm and lip should be somewhat less than 90°.
