Transmission: Automatic AW 30-40

[Volvo Maintenance FAQ for 7xx/9xx/90 Cars](#)

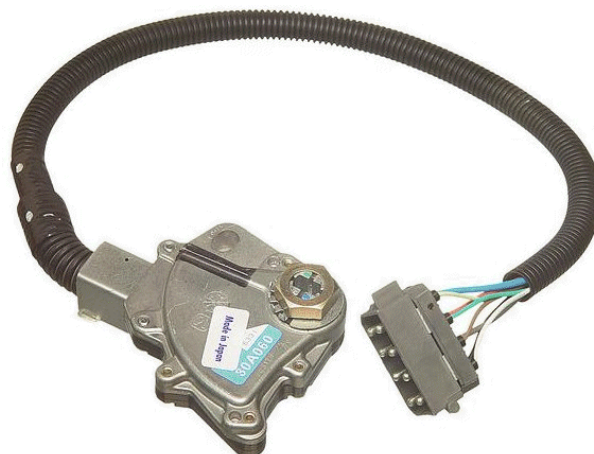
[Inquiry] Does anybody know where the starter inhibitor switch or neutral safety switch is located on the transmission for a 94 960 w/ automatic trans. Also tips on removing it would be much appreciated. I think it is sticking when cold. Starts OK on initial start up for the day, or when warm or hot, but when turned off when cold (anything less than 15 minutes) will not crank. Battery, alt., starter all check out. It seems the trans is not sending the signal to the ignition switch.

[Tips from B and Stan Sexton] The PNP or gear position sensor is located on the right side of the transmission case. It slips over the manual linkage shaft and bolts to the case. The wiring routs to the left side of the trans, where it is attached to a short metal rail toward the front of trans. The pigtails are long and the clips are released by squeezing with a needle nose plier from atop the trans pan lip.

Mine gave out at 48,000 miles. When it fails, you will have 3rd gear only and the check engine and tranny dash lights will go on. The switch R&R at a Volvo dealer runs between \$300 and \$400. I decided to buy the switch from Nils Sefelt Volvo in Houston on the Internet for \$110.00 plus \$8.00 shipping UPS instead, and do the labor myself.
