Interior, Seats, etc

[Volvo Maintenance FAQ for 7xx/9xx/90 Cars](#)

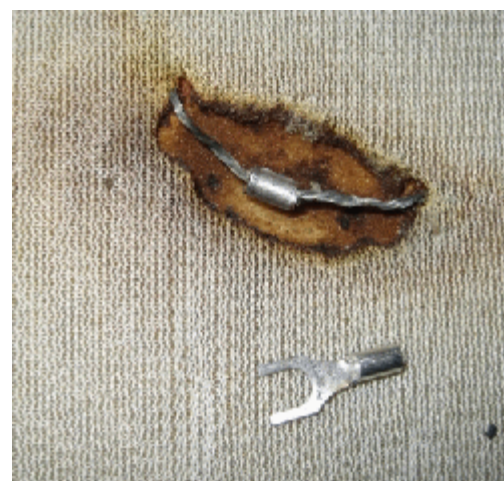
Most if not all seat heater fires (melting smoldering) stem from a shorted element wire in the grid as opposed to the thermostat allowing the heat to stay on too long. Leather seats may be more prone to such problems as leather doesn't breathe plus the thermostat design does not sense seat temperature and thus won't cut out if the seat gets too hot, not that cloth seat thermostats provide much better protection in that regard. Cloth seats (as well as the split leather-cloth seats) use a button thermostat in the face of the lower seat cushion. Leather seat heaters, on the other hand, do not have a thermostat in the cushion, but rather use a relay clipped under the seat. These relays do not sense seat temperature as such, but rather enable heating based on the initial ambient temperature under the seat then set the heating duration based on current draw, followed by indefinite trickle heat cycling. That's based on my own disassembly and testing. All newer style seat heaters (used in 700/900s) use a heating element woven into a fabric pad. Although quite flexible, once damaged these can easily short. The pads are generally not repairable, they're expensive to replace and I know of no direct fit aftermarket replacements. If a thermostat fails, it will normally be to a non-fatal open condition. The button thermostats typically fail when the attached wire connection breaks (re-solder it). A relay thermostat failure is typically evidenced by a shorter and shorter heating cycle. That will either be a circuit board problem (re-solder it) or a component failure (bad/failing resistor/capacitor/diode/thermistor/transistor).

Grid Repair. [John Sargent] I made a repair to the driver's side lower seat heater grid in my 940. The seat heater wires are embedded in a thin layer of foam with fabric on both sides. The seat heater wire is flexible fine stranded wire. The wire breaks where it is flexed the most, generally in the seat bottom. One of the fine strands breaks from flexing, and since the cross section of the wire is reduced, this creates a local hot spot. Where one strand will break, another will break, and the spot gets hotter. Then another strand breaks, and it gets hotter yet until it fails. The broken (burnt) spot in the wiring is quite obvious, you can't miss it. I pulled enough wire out from both sides of the break to pull the ends through the crimp sleeve I made from a stake on fitting. I cut the fork off of a stake on fitting like is shown in the picture, and pulled both ends of the wire through the sleeve I'd made, and crimped it very hard. It is sure a lot easier than soldering wire that as been hot, and pressure connections are much better for carrying amps than solder connections are. I then made a repair to the seat cover over the wire.

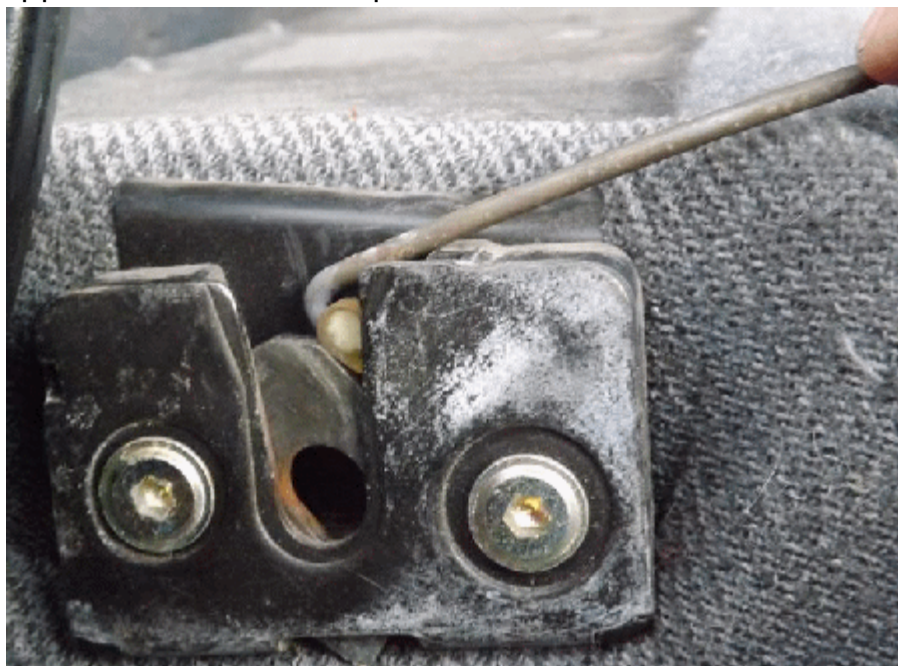
- At this point, if your seat is jammed, flip up the bottom portion. simultaneously pull the upper release rod and push the lower release rod to the left (till you hear a click) and shimmy/push the seat out of its jammed position and get it to fold down, this will likely reset the seat retainer/locking bits, unjamming the seat. if the upper seat release is stuck in the closed position, but not engaged in the retaining hook/rod, pull the upper release rod to the left and rotate the seat release towards the back of the car (counter clockwise)

and release the rod. this will reset that lever mechanism so it will catch and lock in the retaining hook/rod.

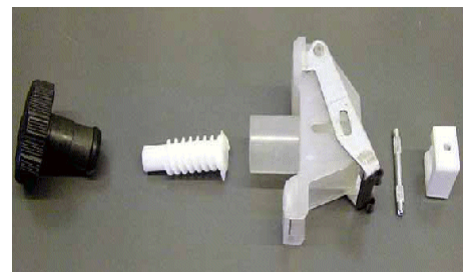
[*Bob/John Hibbert/Rodrigo Silva Solution*] I had the same problem with my 93 945. The most common failure is a broken adjustment bracket screw: the large white screw in the photo which separates from its square end support piece on the other side of the adjuster. This is a design fault. [IPD](#) sells a rebuild kit for US\$65 that contains all needed parts. The following are the steps I followed:

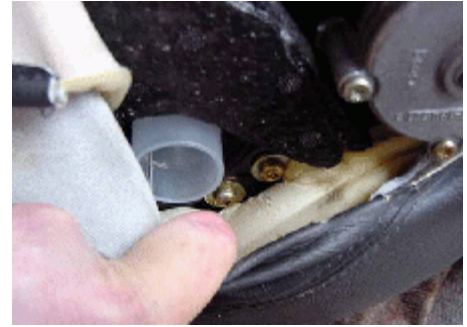
10. Remove the mechanism from its internal location. The problem will now be obvious and most likely be a break in the plastic bolt-like fixture. It has a hollow rectangular head. Mine was broken through this head. This head has a pin passing through it.

11. You now have two options- install the rebuild kit for \$65US -or repair by placing a 10mm bolt through the centre of the adjuster to tie it together and strengthen it.

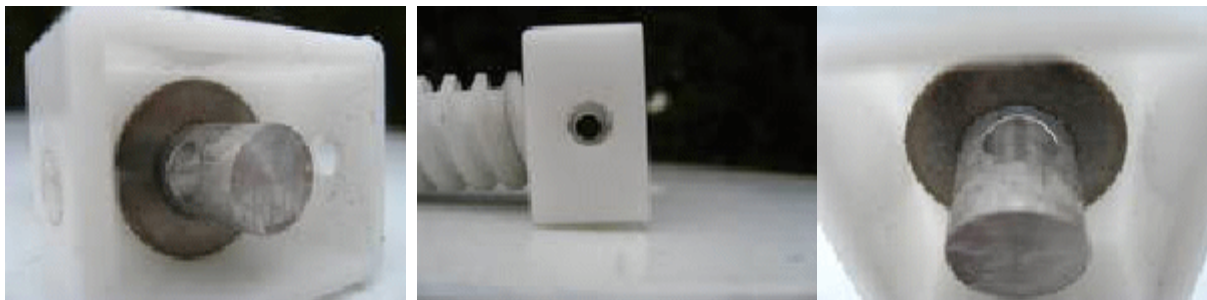
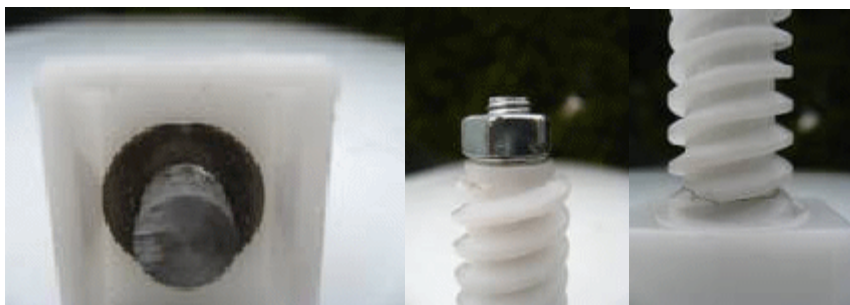
Here's my overly-complicated method of fixing the cheesy-engineered lumbar support on my 1989 740T wagon: I held the broken pcs together and used a suitable transfer punch to locate the center of end part. Then glued the broken pcs, using crazy glue or equivalent (cyanoacrylate). Starting with a 65mm long x 9.55mm dia (3/8") alum rod. 55mm of the rod is machined to ~8.8mm, as the inner clearance of plastic threaded part is 9mm. The end thread M8 x 1.25mm is secured with loctite. Once part is tightened down, I drill the 5mm pin hole in head of 3/8" rod. Photos below.

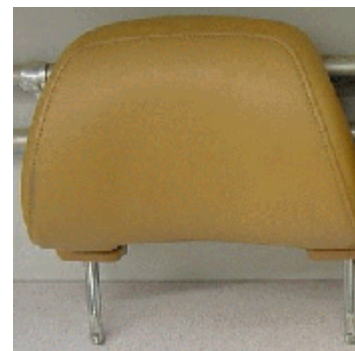
[Andrew] Just below the headrest on the back - just where the fabric can be pressed in - toward one side (about three-four inches from the side edge) I found/felt a wire lever (seemed to have a small loop/circle at the end). It was horizontal mainly - from the side. Worked my fingers and pressed it - released the headrest. It does require some pressure.

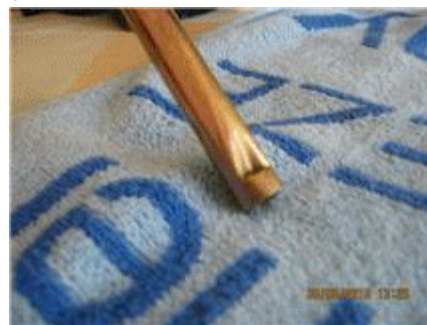
[Jay Simkin] As you face the back of the seat, you will see there is a rear seat pocket. About nine inches above the top edge of the seat pocket, there is a line of stitching, which runs from right to left, about 5" below the top of the seat (there are also lines of stitching, that run down towards the top edge of the seat pocket). About one inch above the top line of stitching, there is an angled area, where the fabric is stretched, so that the central part of the seatback forms a recessed panel. About 1.5" above the top line of stitching, you will feel - when you press gently forward (i.e., as if you were going to press your finger through the seat, to the front surface [that closest to the steering wheel]) the edge of a frame. Using your index finger, press gently but firmly forward, directly below where the foot of the headrest joins the seat, right below the frame and about 1 1/2" to the inside of the angled seam. When you have pressed your index finger 1 - 1 1/2" forward, you should feel something springy. It will move forward, as you press on it. This is the headrest catch release lever. The front edge of the steel headrest post has a notch in it. The headrest catch locks into that notch. When you press forward on the headrest catch release lever, you disengage the catch from the notch. It is sometimes helpful to push down on the headrest, push the headrest catch release lever forward, and then pull up on the headrest, to disengage the headrest catch from its notch on the headrest post. You should free each side of the headrest, by lifting each side 1/2", before trying to pull the headrest out of the seat. To re-install the headrest, simply align the posts with the holes, and push the headrest downwards. It will automatically lock into place. [Dave Richards] Sit in the rear seat with a piece of timber about 25mm thick by 75mm wide and 1.5metres long pushed thru the gap between top of seat and bottom of head rest. Place a towel and a piece of timber on dash for protection. Rest end of wood through seat on top of packing on dash, then put your shoulder under other end and provide upwards pressure while pushing on seat back with knuckles or thumbs slightly to the outside of each headrest tube and about 80mm down from top of seat. The actual lock is a cut and pressed whistle notch 3mm deep in the 12mm diameter tubes; the notches are facing the windscreen.
