Driveshaft, Driveline, Rear Axle

[Volvo Maintenance FAQ for 7xx/9xx/90 Cars](#)

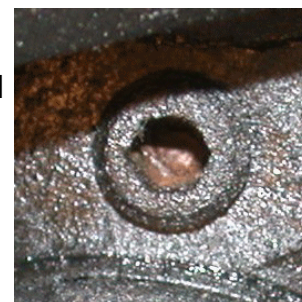
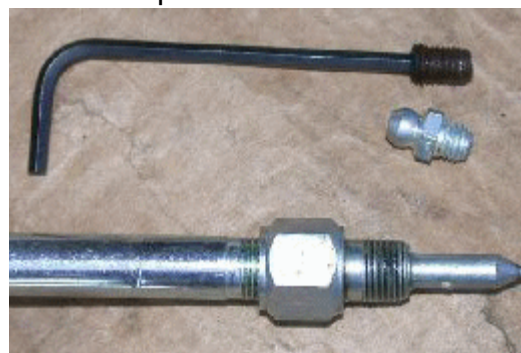
Lubricating U-Joints. [Art Benstein/Randy Starkie] Every Volvo driveline u-joint I've had the pleasure of examining can be lubed (740 and 940 included). They have plugs (1/4-28 Allen head screws). I run the screw out and put a zerk in temporarily to squirt in my probably incompatible grease, and then replace the plug. Use a 1/4" socket that fits in the confined space to install the Zerk. There is not enough room to get a regular grease gun end in there to lube them. Use a grease gun with a conical tip that simply presses against the fitting to pump the grease in.

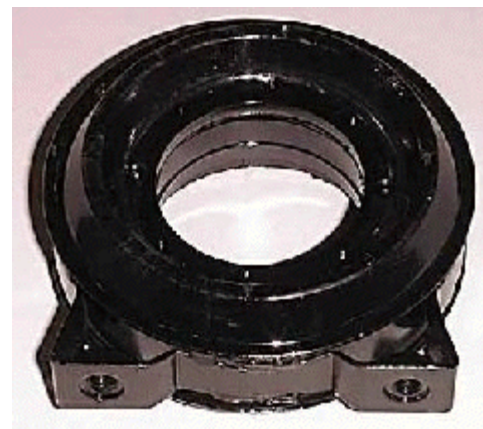
Diagnosis. [Response: Mike Froebel] Classic hanger bearing noise. This is located just in front of the center universal joint on the driveshaft. There is a plate that is bolted to the frame rails with 2 bolts per side, the hanger bearing support is bolted to this plate with 2 bolts. The bearing lives in this support. [Editor] Don't drive the car extensively when it has a failing driveshaft support bearing. This can fail catastrophically and send the driveshaft flying at high speeds. When it makes noise, it needs repair very soon.

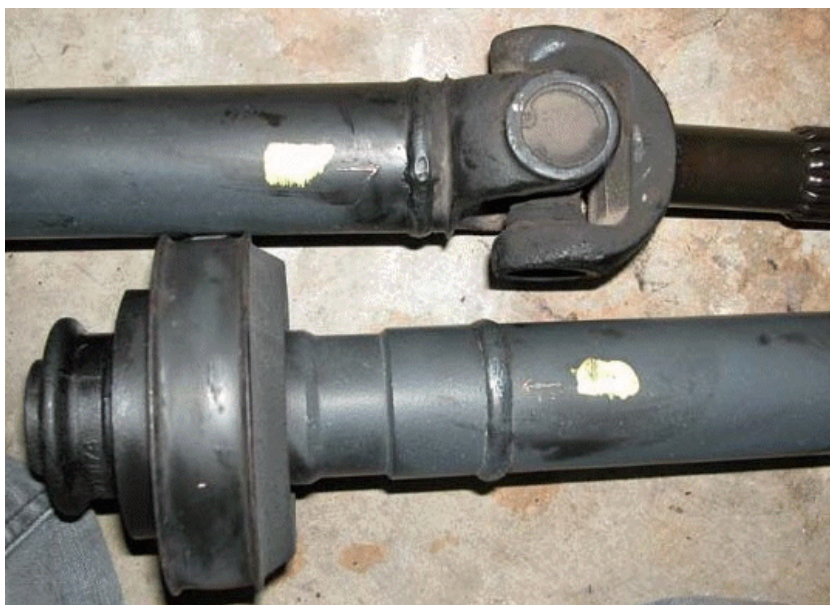
[Response: Dennis Hamblet:] The front section must be kept in the same alignment with the back section. The only approach I could suggest if yours appears out of whack is to remove the center bolts and rotate the rear shaft 1/4 turn then try it again. If it cures the vibrations you're home free, if not, rotate another 1/4 turn till you've tried all 4 combinations.

[Response 2: Warner Bowles] I believe that the yokes of the universals at the centre bearing have markings on them from manufacture which indicates the correct alignment. You will have to clean off the paint and any other build up which has accumulated on the yokes to see them. A second alternative is to ensure that the yokes on the universals at the centre bearing are parallel, (ie in the same plane). This will result in the universals working together rather acting against each other. If worse comes to worse you may be 180 degrees out but should still reduce the vibration.

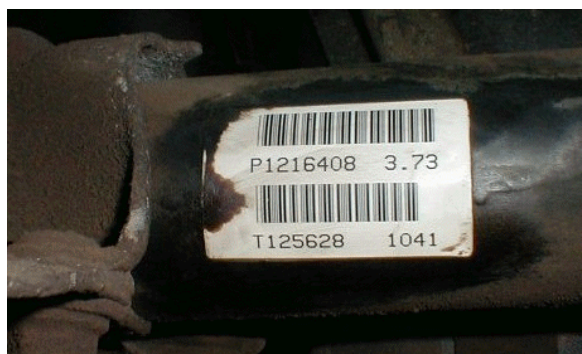
[Response: Rob Bareiss] If you look under the back of the car, and see a big round differential in the middle of a tubular axle, that's the "live" or regular "solid axle" rear.

If there is a big framework in the center and long control arms running from center out toward each wheel, then it is multilink (Independent Rear Suspension). The only cars with IRS are: late 760 sedans, 940SE sedans, all 960 sedans, late 960 wagons, and S&V90's.

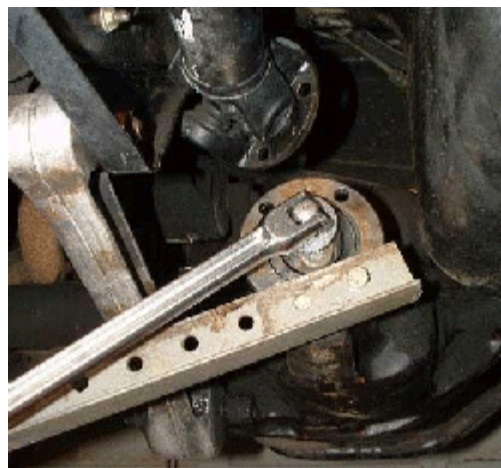
The tool looks something like this:

Bad representation, but hopefully it gets the point across. I bolted this tool to the flange attached to the rear end and bracketed it against the ground, I have something to work against to loosen that nut.

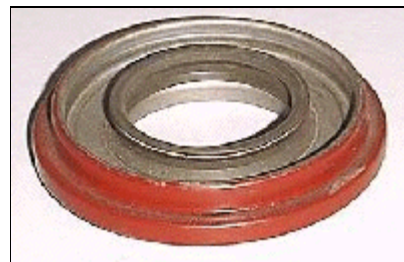
Remove the [pinion flange](#) that the drive shaft bolts to, first marking it in relation to pinion so as to preserve its position since it will unbalance the driveshaft assembly if not put back into position as it was. Drain the rear differential oil. [See below] Remove the [center flange nut](#), then remove the flange with a puller; no hammering allowed! Seal ("1" in the photo below) can

be removed by any reasonable means that doesn't scratch the opening in the diff housing where seal fits. You can put a good-sized screwdriver in between the seal and the pinion shaft and pry it out. It will distort and tear but will come out. Some respondents have not found this very effective: if so, try the following advice to bend the seal housing lip over. Whatever you do, DON'T damage the housing or shaft.

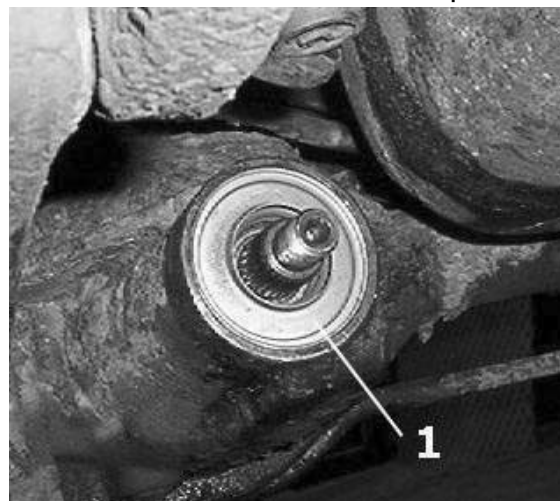
It should pop out with no problems if you did it right. There is a large washer behind the seal, next to the bearing, which you can remove using a dental pick or magnet. Insert a paper towel or other dirt block: don't let debris enter the bearing. Carefully clean the flange where it contacts the seal, removing any rust to ensure the new seal fits.

You can use a Dremel with a fine stone to remove rust and clean up any nicks if you are careful. Make sure you install the seal right way around: "outside" is stamped in the metal seal ring. Put a little grease on the seal surface and spring so it won't rotate dry and then tap it in place. The new seal will need

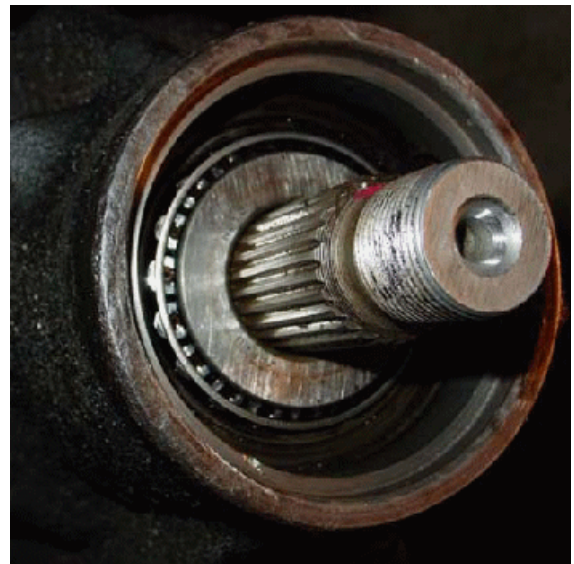
to be driven in evenly to be just below flush with front of diff housing unless it is one with a lip that stops it when the lip contacts the diff housing. You want it deep enough so the flange does not rub on the outer steel portion of the seal. If you have a socket that is about the size of the seal use that to get it in even, if not just keep at it gently until it is seated evenly all the way around. A brass hammer works well. Re-install flange as marked and tap it onto the greased shaft far enough to engage the splines about 1/2". Reinstall the counter hold tool, refit

the nut (Volvo recommends a new nut), and tighten the nut to push the flange home. The torque depends on whether your seal uses a compression sleeve or not. **NO IMPACT WRENCH ALLOWED, TORQUE IT!!!**
