Radio and Antenna

[Volvo Maintenance FAQ for 7xx/9xx/90 Cars](#)

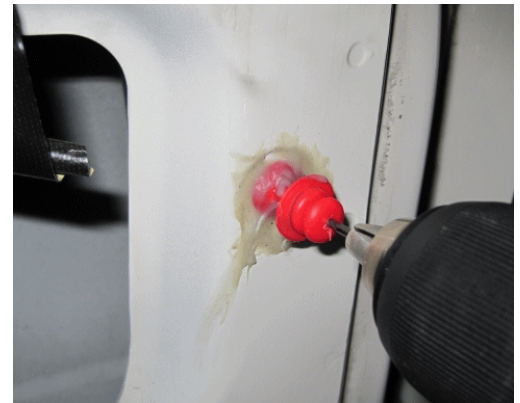
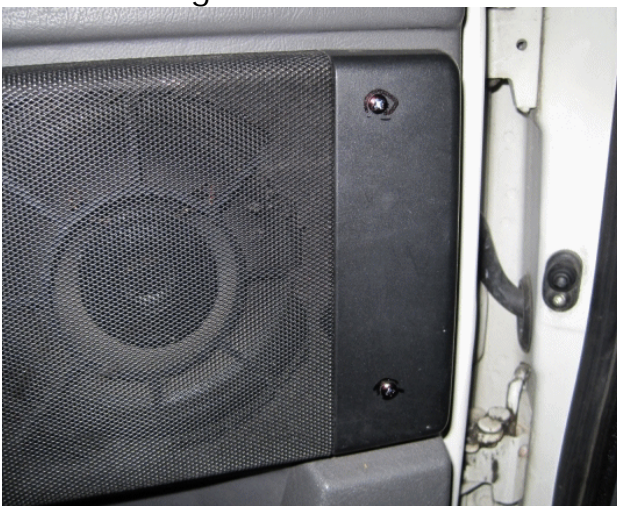
Door Speaker Cover Removal and Repair.

- *Repair.* [John Sargent] As anyone who owns a later 700 series, any 940, or an early 960, the front speaker grills are junk. They are used to hold the door panel on and over 90% of them are broken. New front speaker grills at \$25 at the dealer. Not bad, but you can save some money with my method. I glue the red mounting posts to the door with epoxy so they won't spin when you turn a screw into them. The picture shows the epoxy and drilling the center of the mounting post. I started with a small drill bit, and finished with a #30. I drilled the speaker from the back side, so I could see the approximate center of where the head of the red mounting post would be. I used #6x1" sheet metal screws to mount the speaker cover and touched them up with a Sharpie. An alternative would be to epoxy (using Devcon brand Plastic Welder) a speed nut on the back side of the door, in place of the red post, and use longer sheet metal screws.

- Push the plastic speaker cover forward toward the front of the car to pop it off the mounting posts. If stuck, push in on the door panel while pushing the cover forward. The 5-1/4 inch speakers are riveted into the door panels. Drill out the rivets to remove the speaker or cut off the rivet heads with a cold chisel and a sharp tap with a hammer. Replace either with new rivets or screws and nuts with Loctite to prevention loosening. Inspect the harness to make sure the insulation is intact as it passes through the door post. [Herb Goltz] Speaker covers often break at the bottom mounting clip, causing them to loosen or fall off. The red plastic studs sometimes break too.

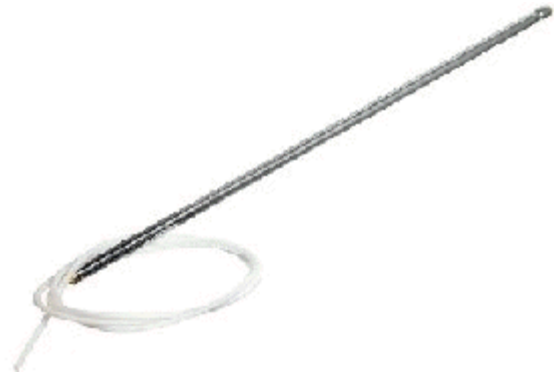
Antenna Mast Basics:

The mast and the nylon line come in one unit - about 20 bucks or so, so don't bother trying to fix the existing one. The mast is attached to a nylon cog line that rewinds down into a housing attached to the motor. When the line breaks, the end can remain in the housing, in which case you need to loosen the unit to open the housing enough to get the piece out. The nylon cog has gear teeth on one side: these teeth face the front of the car and are gripped by the rotating gear inside the motor case.

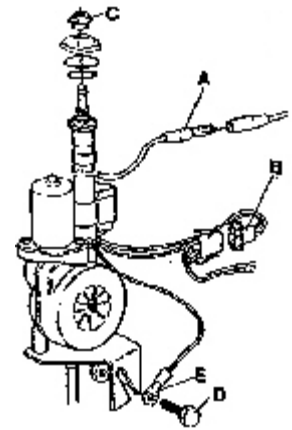
Disassemble carefully, keeping all parts in order, by removing the central nut from the round takeup device. There is a silicone gasket, so try not to pry it. No need to remove the motor itself. There is one snap ring inside holding the takeup reel on the main shaft. Remove this reel (the large gear) and degrease it, along with the circular mast storage reel above it, the small guide rotor, and the input shaft. Carefully lube the shaft and reassemble. Then follow the instructions above for reinserting the antenna mast.
