# Heater Core Replacement

## A Guidebook with Pictures

This guide was compiled while following the extensive manual at the Brickboard FAQ. While the manual is very good, this pictorial guide should serve as a helpful supplement for the brave people who undertake 700 series heater core replacement. Good luck to you all! It's actually not that scary.

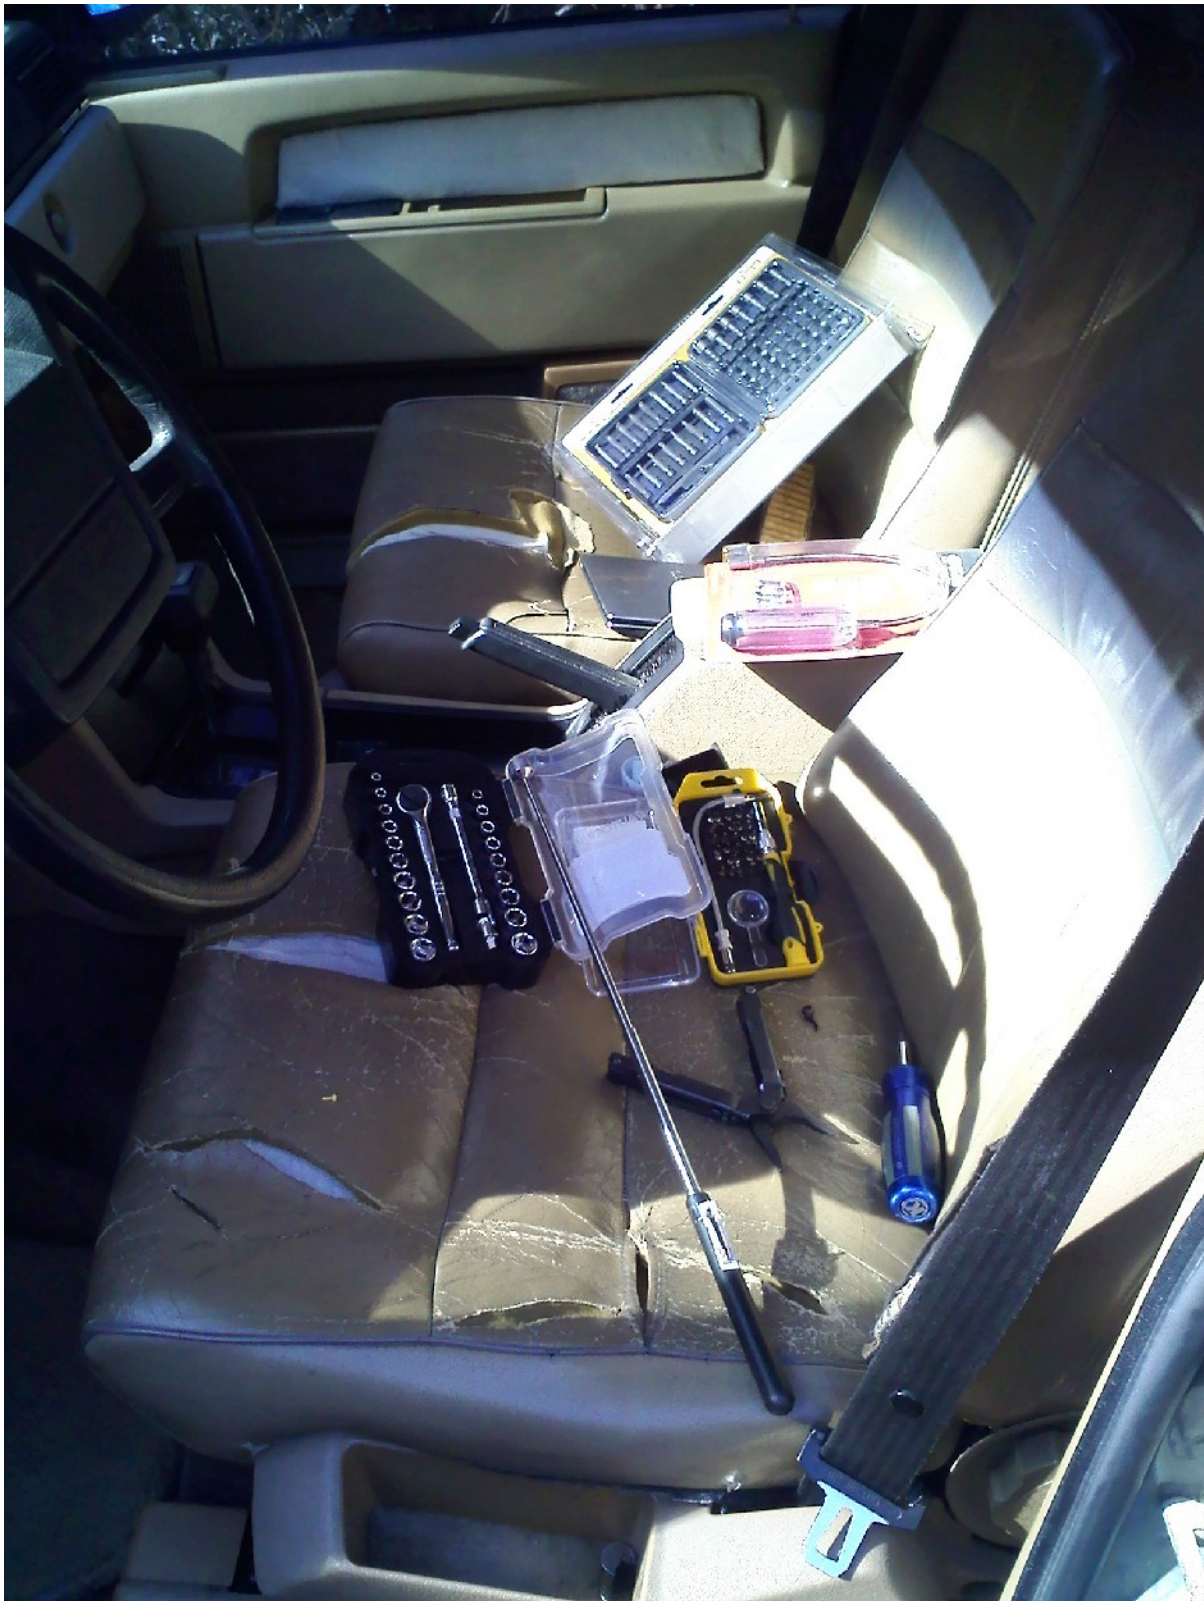
My toolkit was basic, and included a 1/4" drive socket set with some extensions and a bendy thing. Screwdrivers (or a multi-tip one), a leatherman tool, plus a telescoping magnetic wand rounded out the required tools.

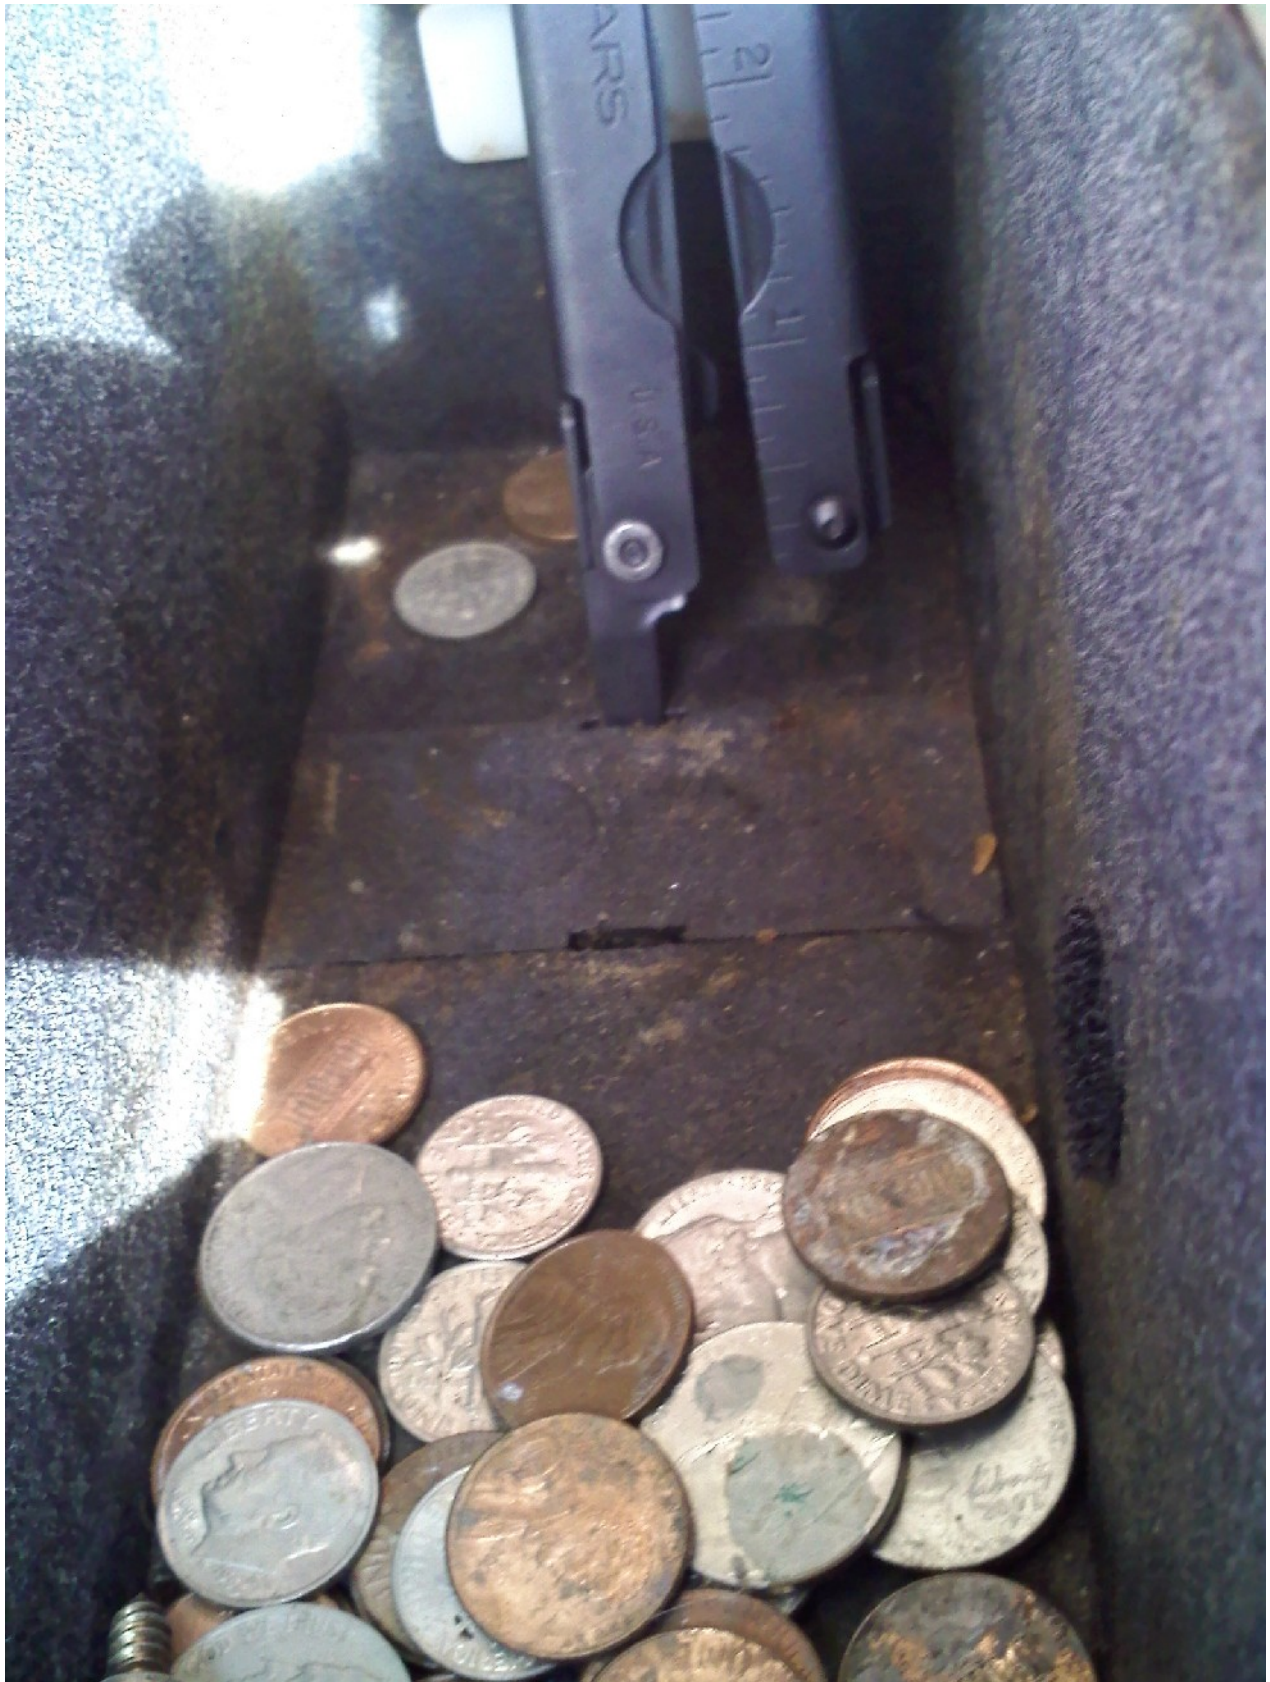
Inside the center console, pry out the cover for the screws that hold down the console.

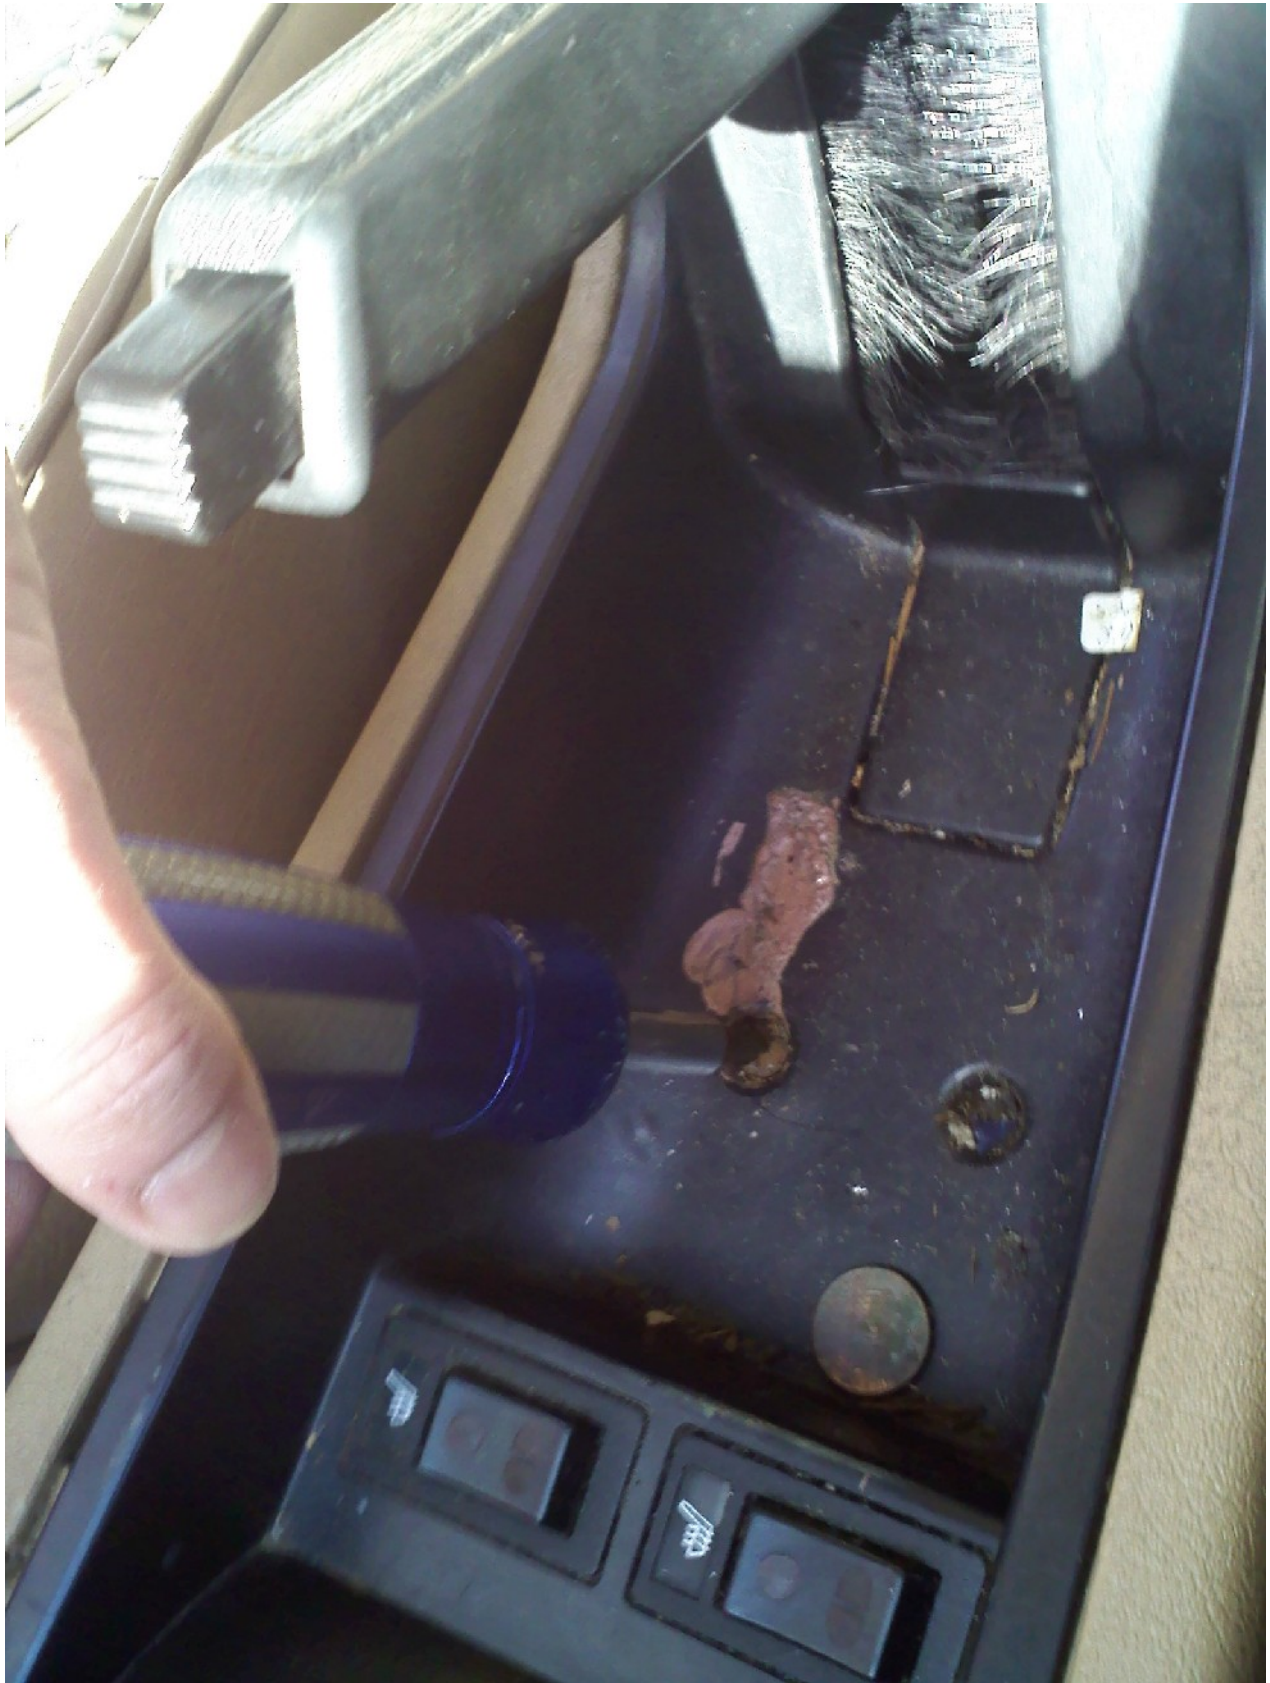
Remove the two screws under the e-brake to detach the center console from the transmission tunnel.

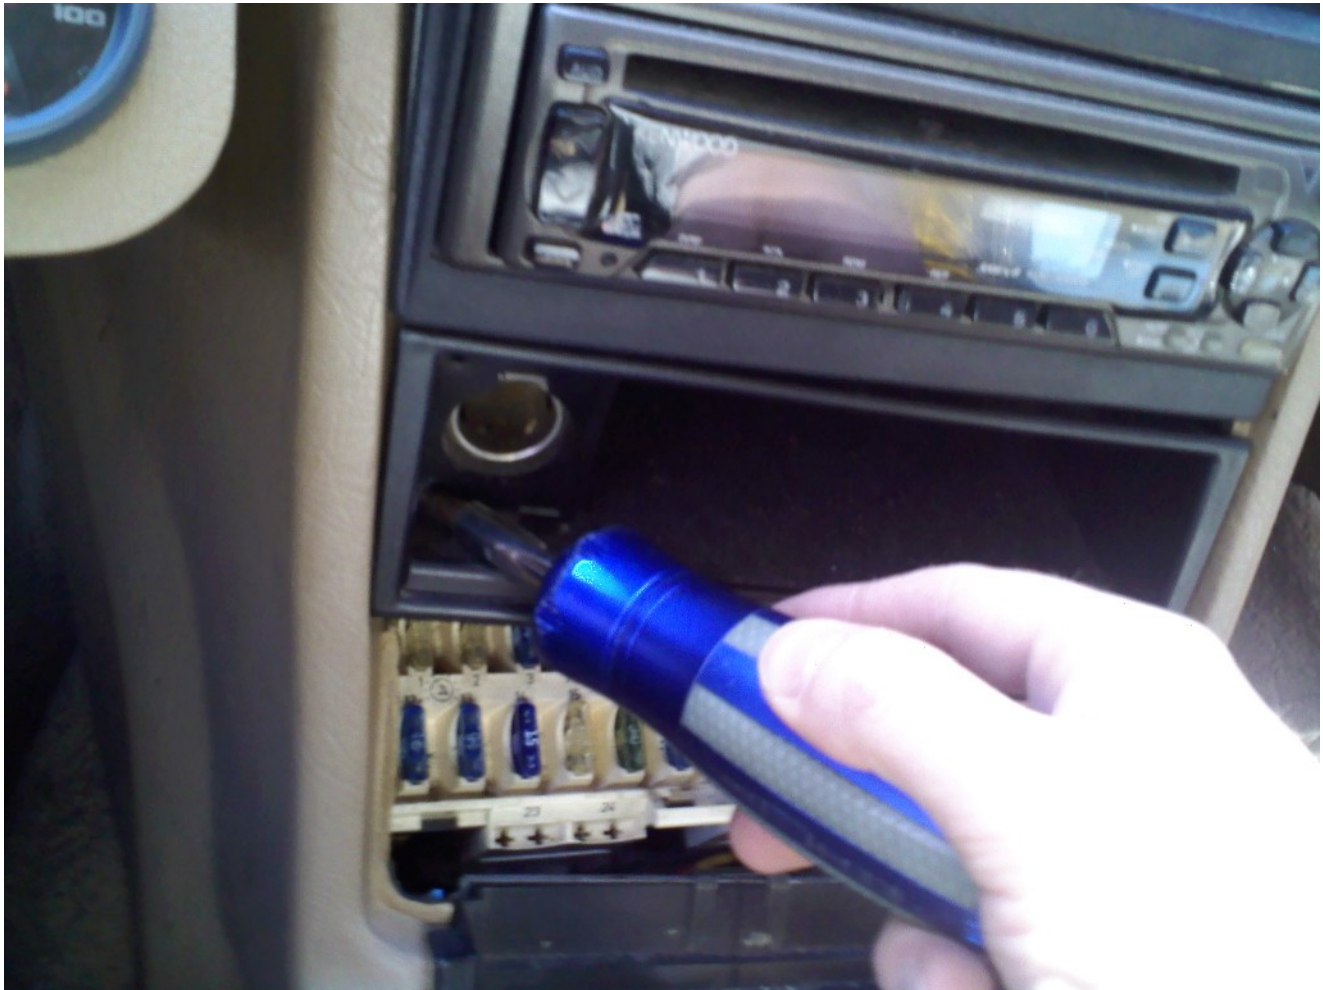
A couple of screws hold on the little cubby above the fuse panel. It will pull out.

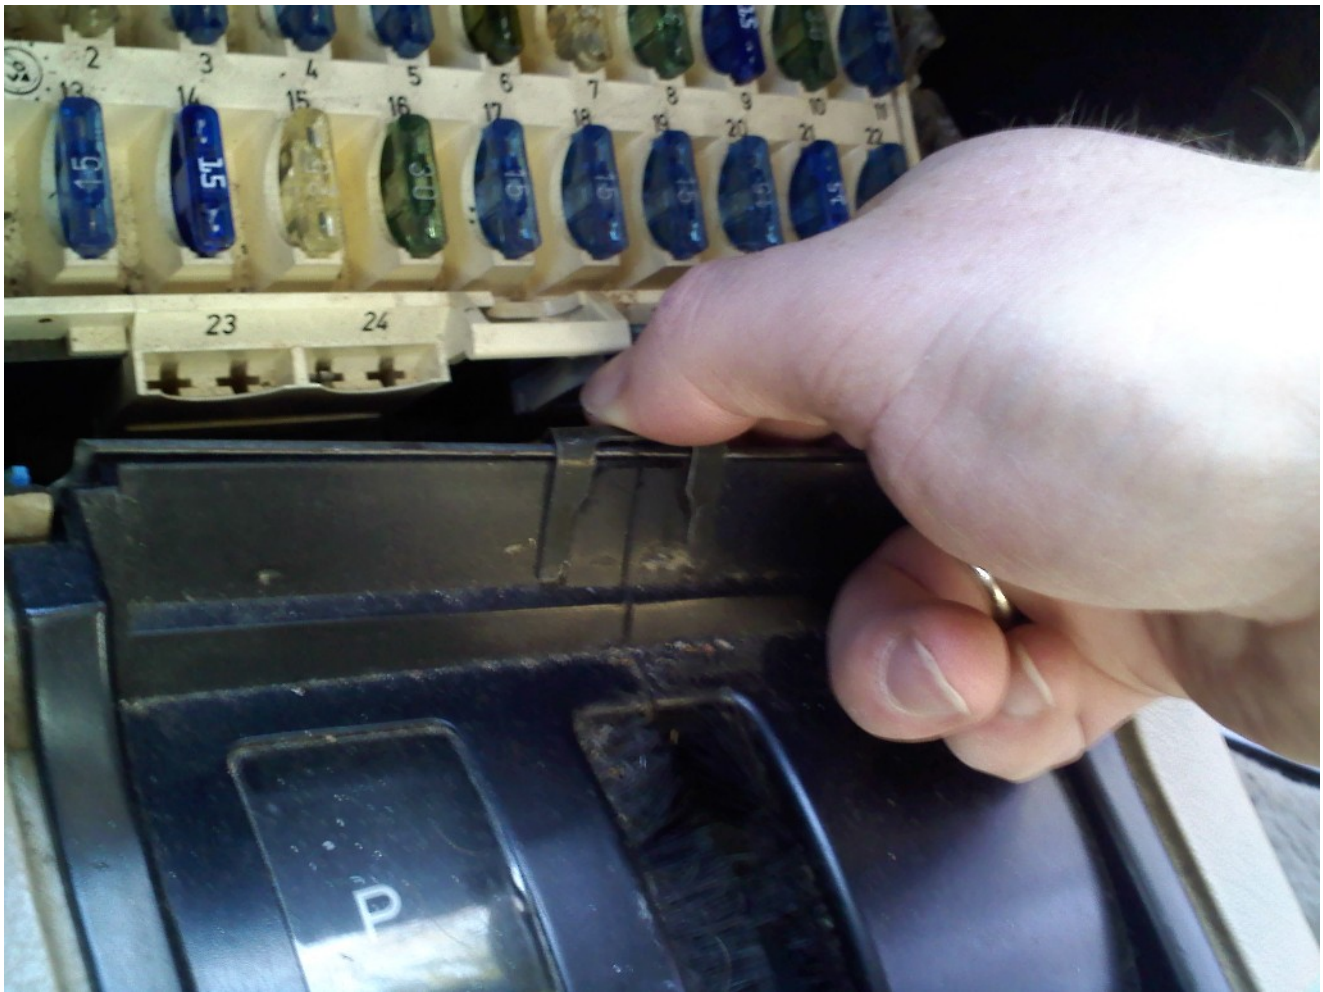
The clip above the shifter is a pain! Be careful not to lose it down there when it pops off. Do not use tools to pry it or you risk breaking stuff.

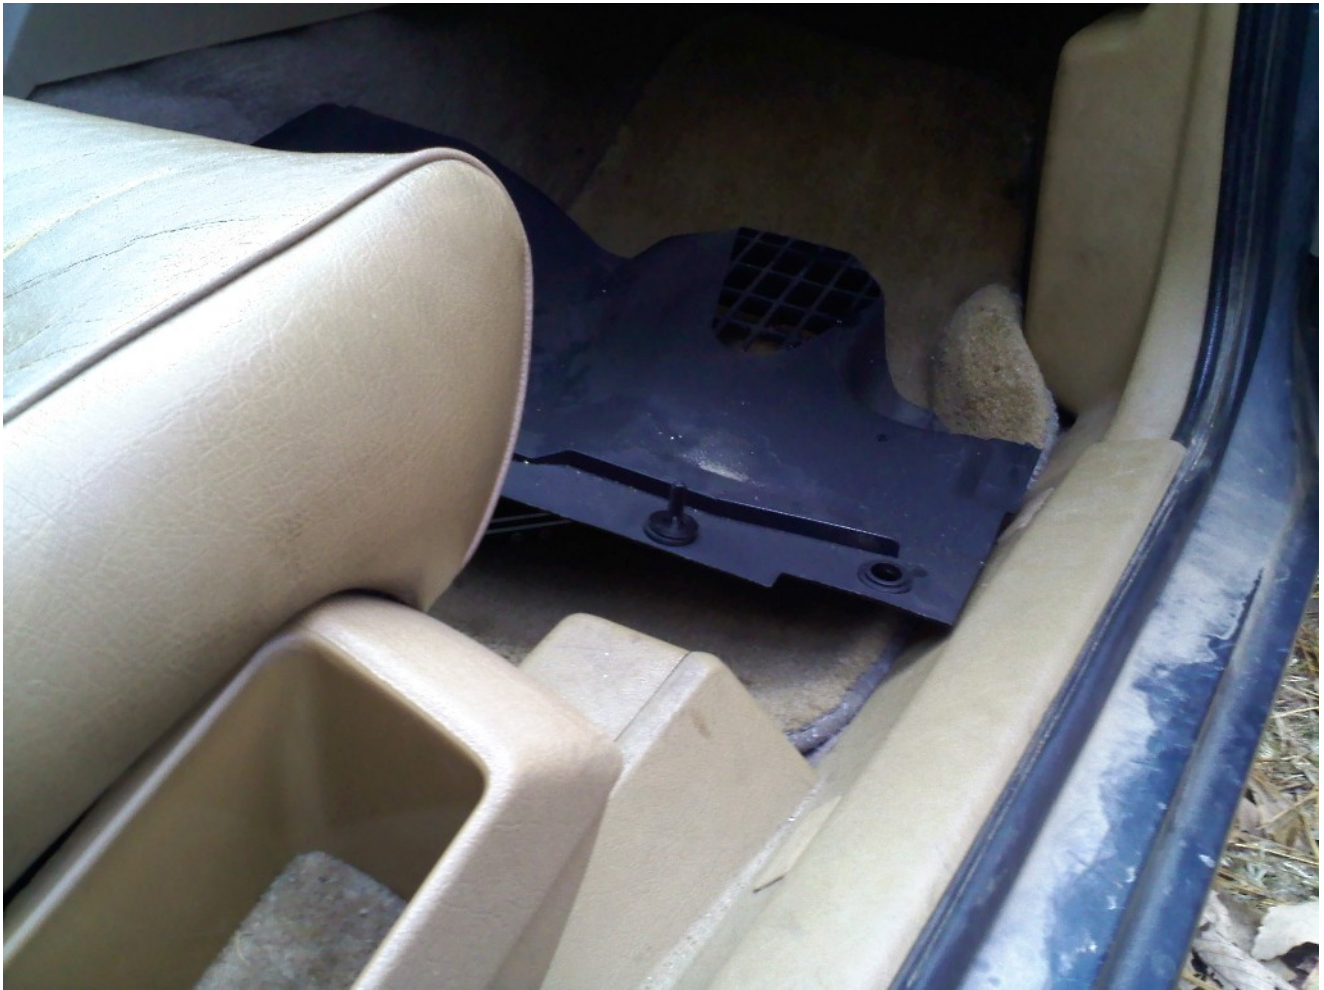
Passenger side knee bolster. The clips that hold it on are these ratchet plastic screw things. Turn them 90\* and they should come out.

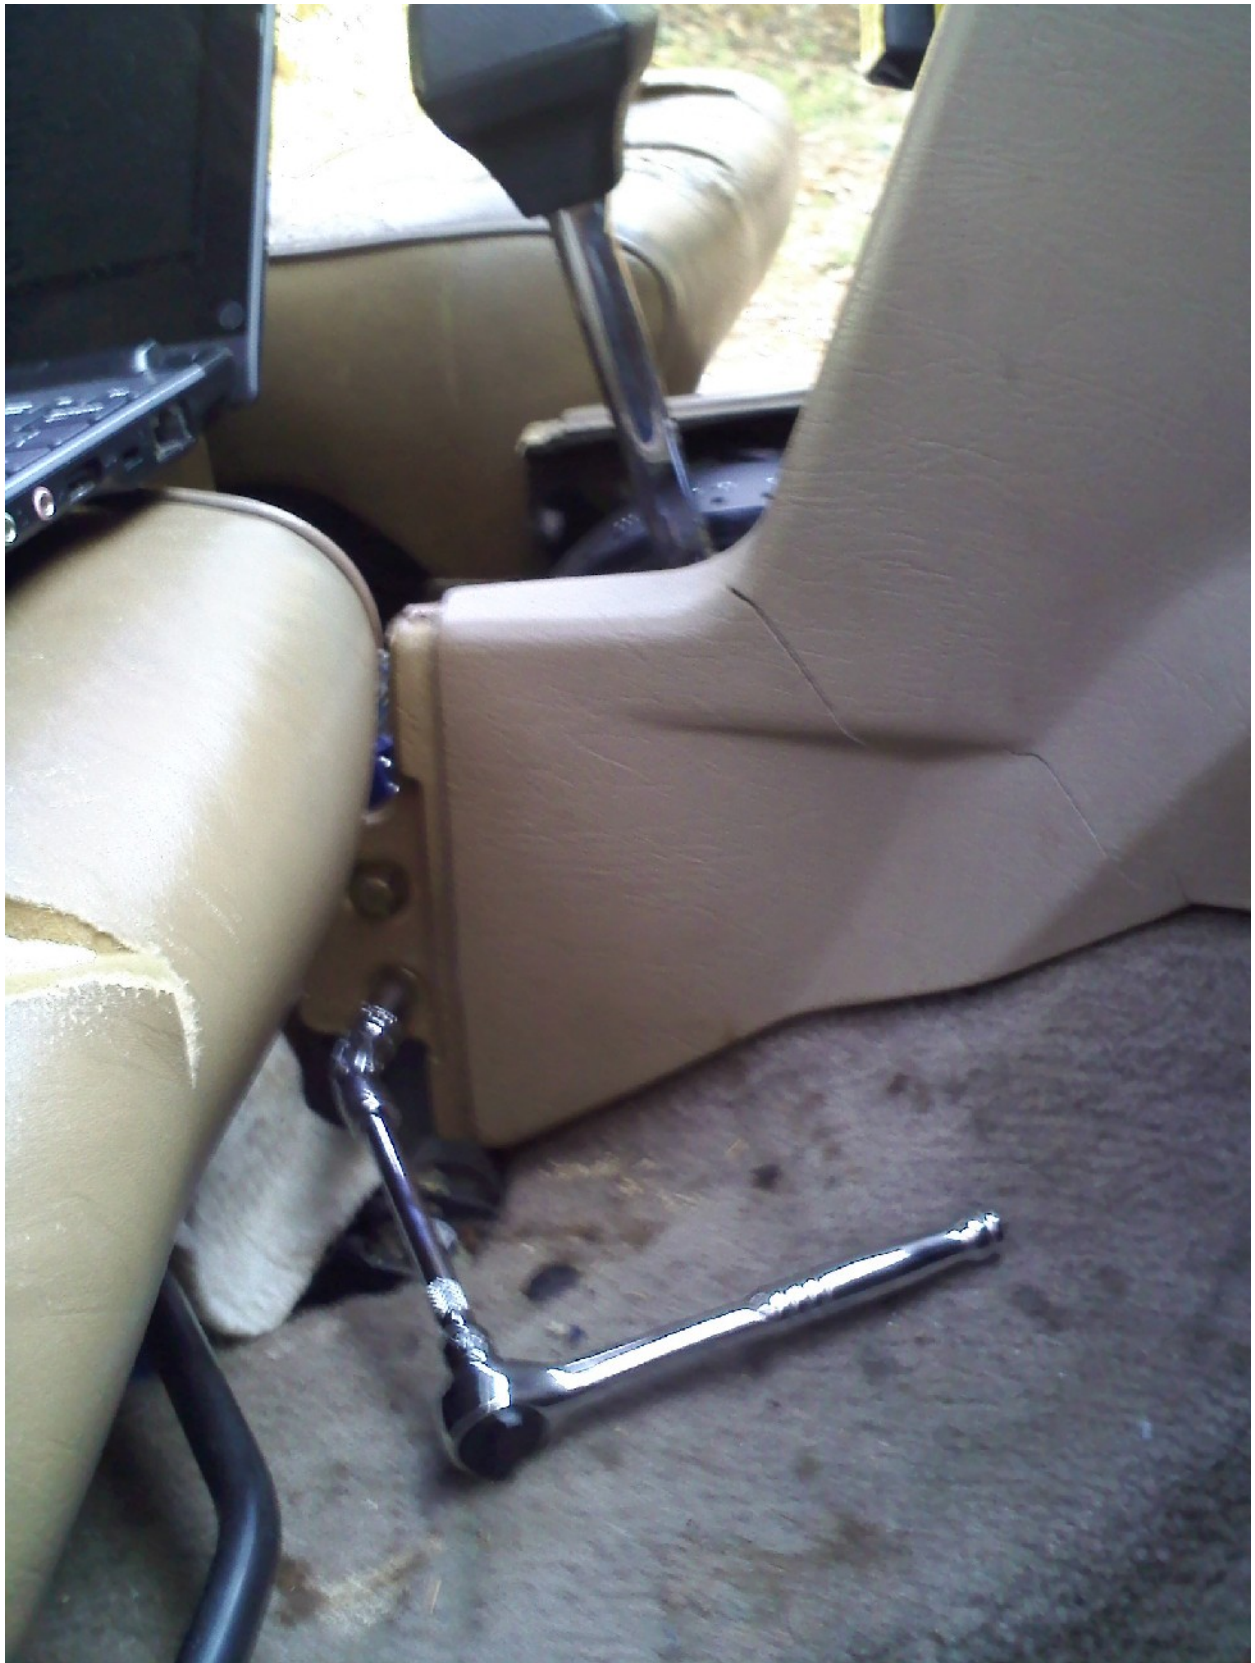
Two bolts hold each side of the kick panel to the transmission tunnel. Take them out.

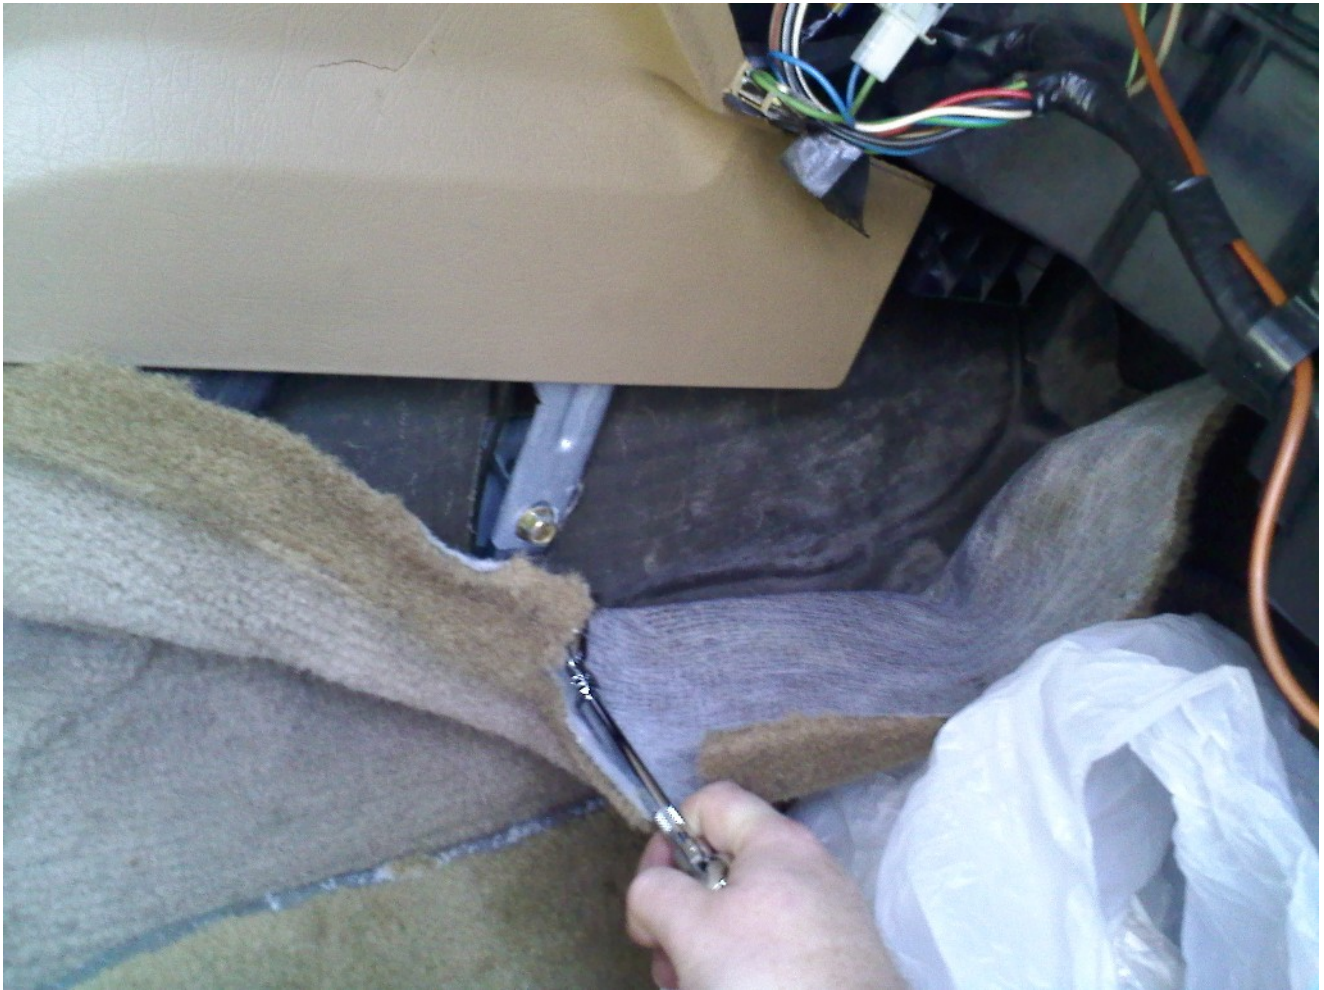
One bolt on each side, near the firewall end of the kick panel. Pull up the carpet to find it.

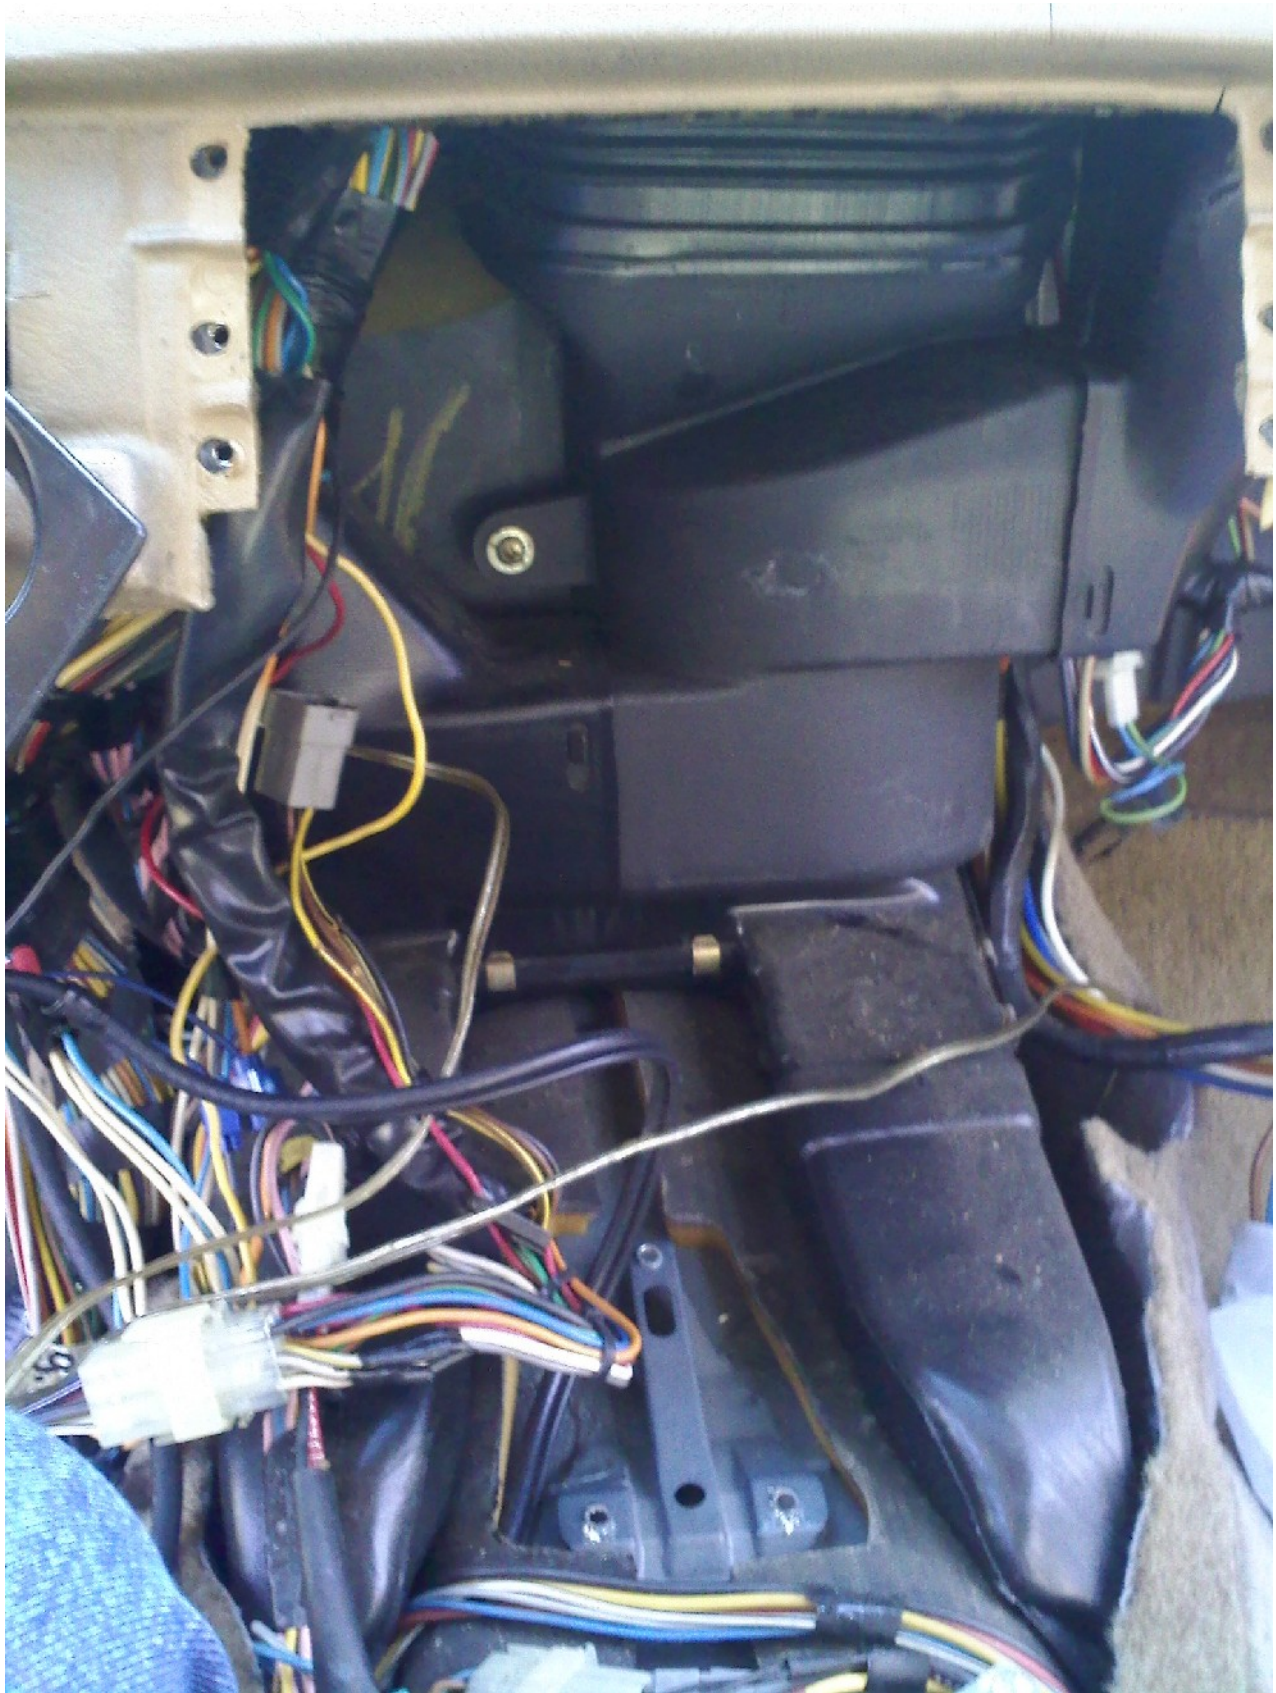
This is the duct maze in front of the heater core. It all has to come out.

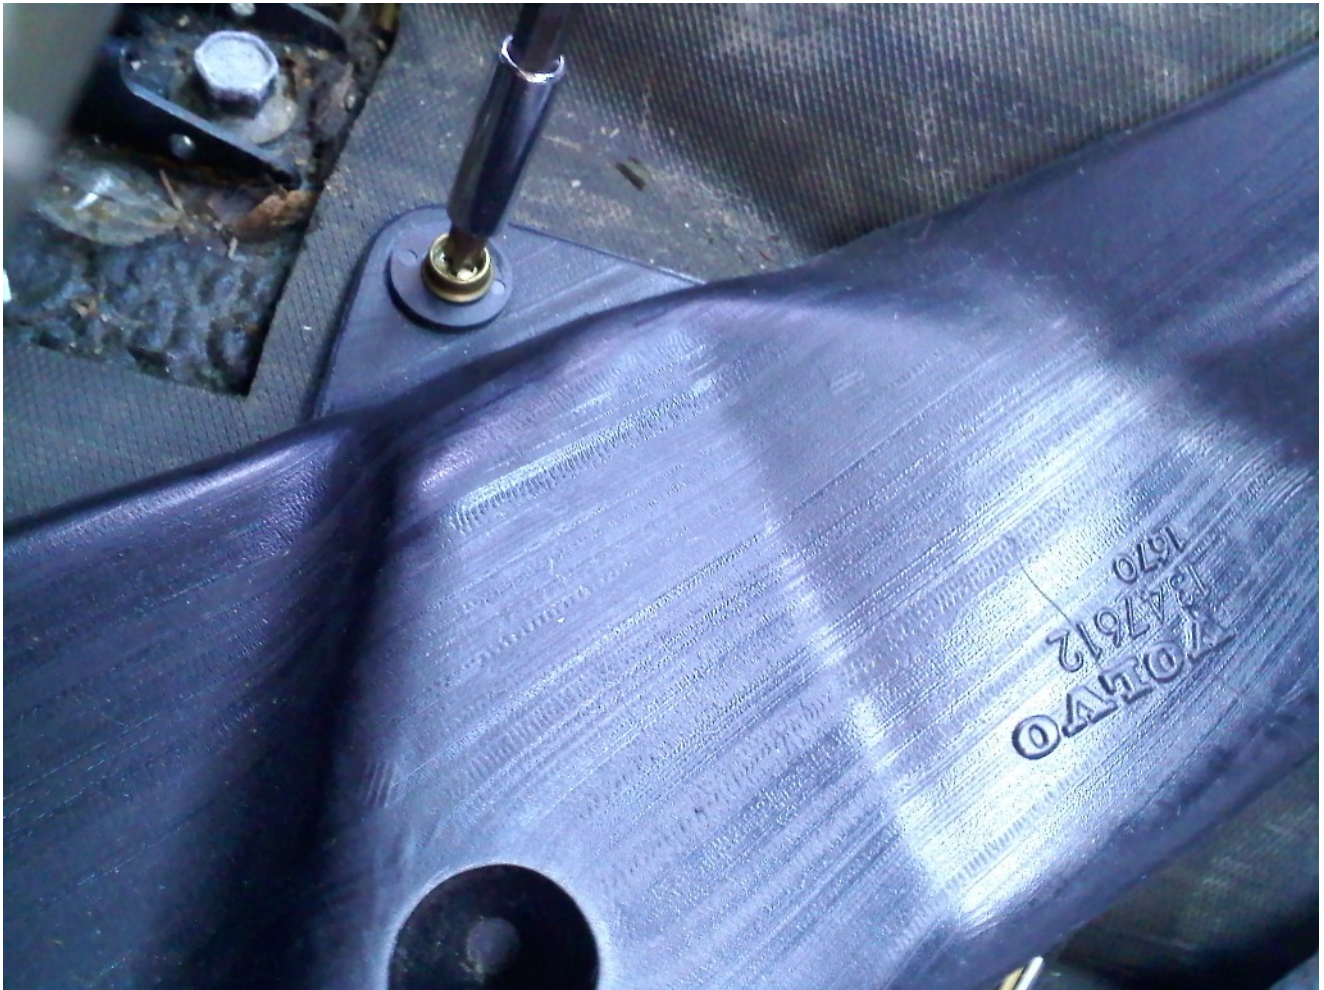
The snap thing around the phillips head screw is not part of the screw. Don't lose it, and do store it with the screw so you remember to put it back on.

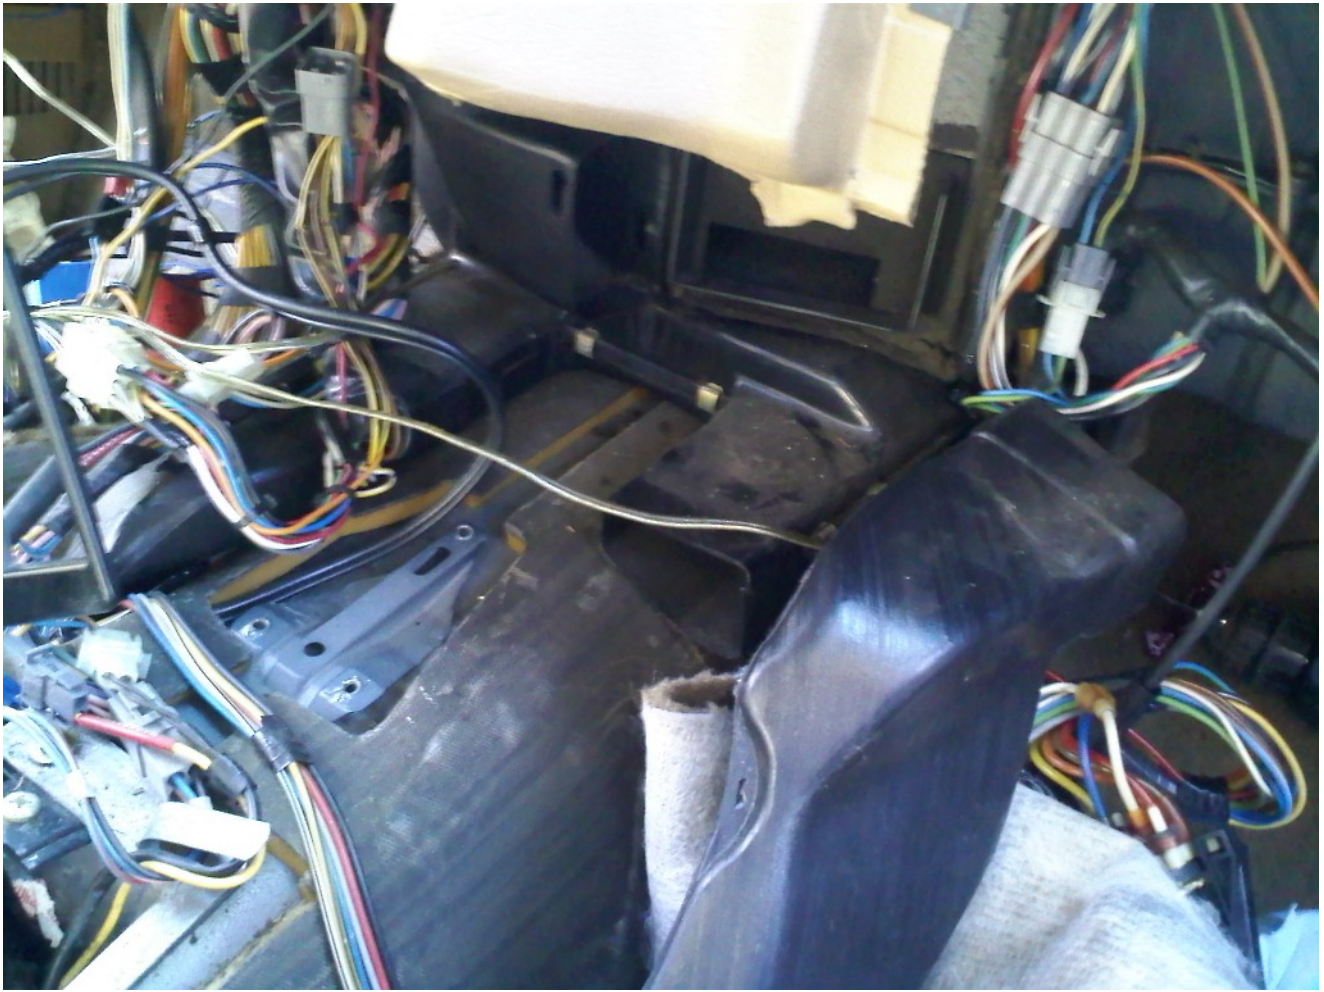
This floor vent distributor is actually very brittle and stiff. Be careful with it. It will have antifreeze all inside it, so be prepared for dripping. Pull sideways to the left and up to get it out. It will catch badly on the pad underneath. I had to finally cut mine free after 20 minutes of struggling.

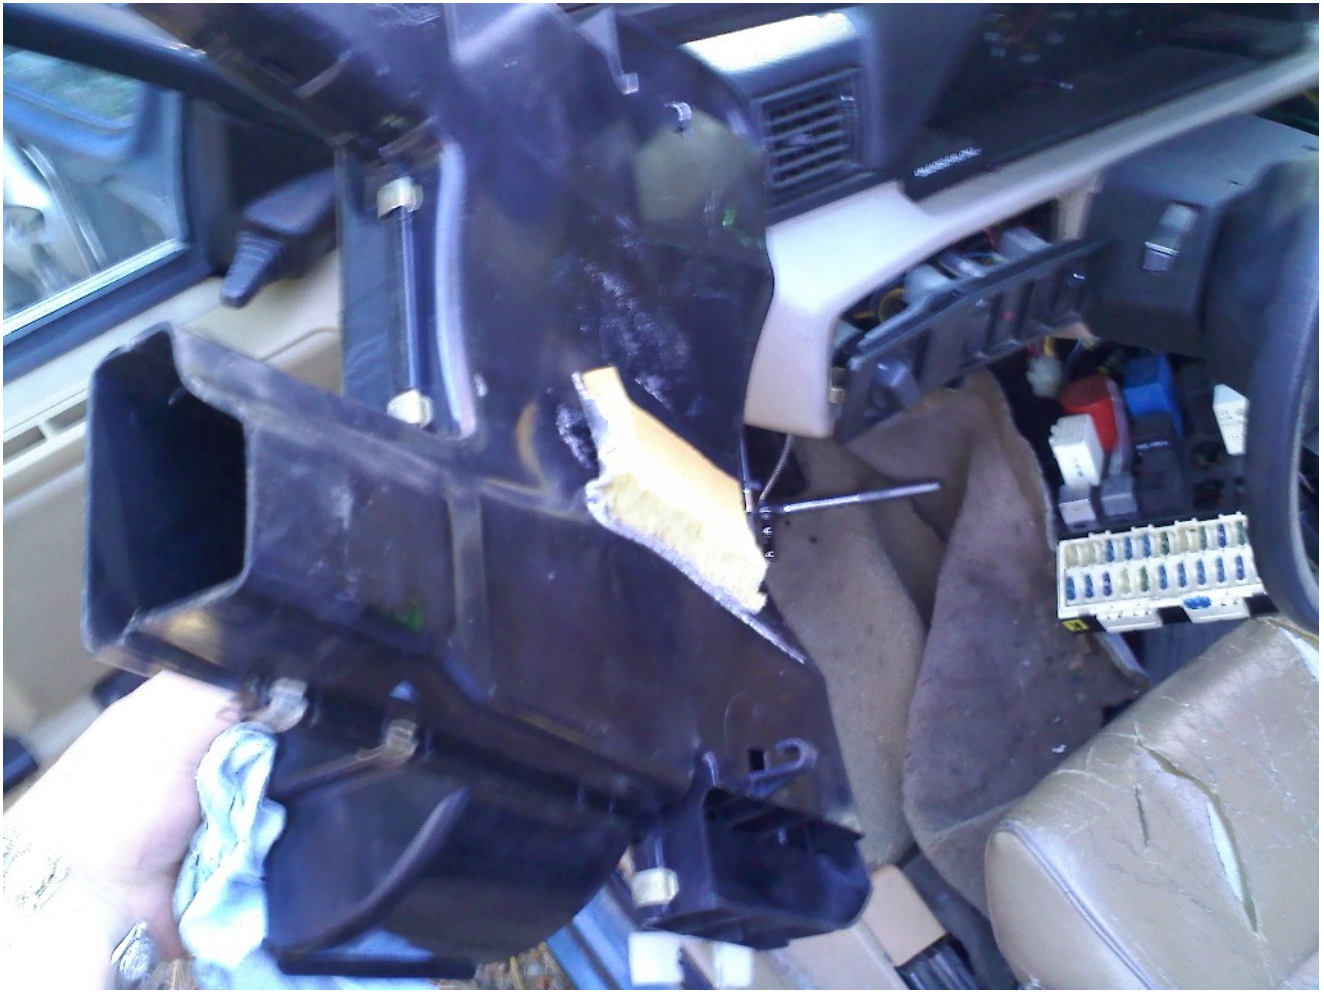
Some sort of adhesive, or perhaps just crystallized coolant, adhered the box to the foam underneath. I cut it where it began to tear.

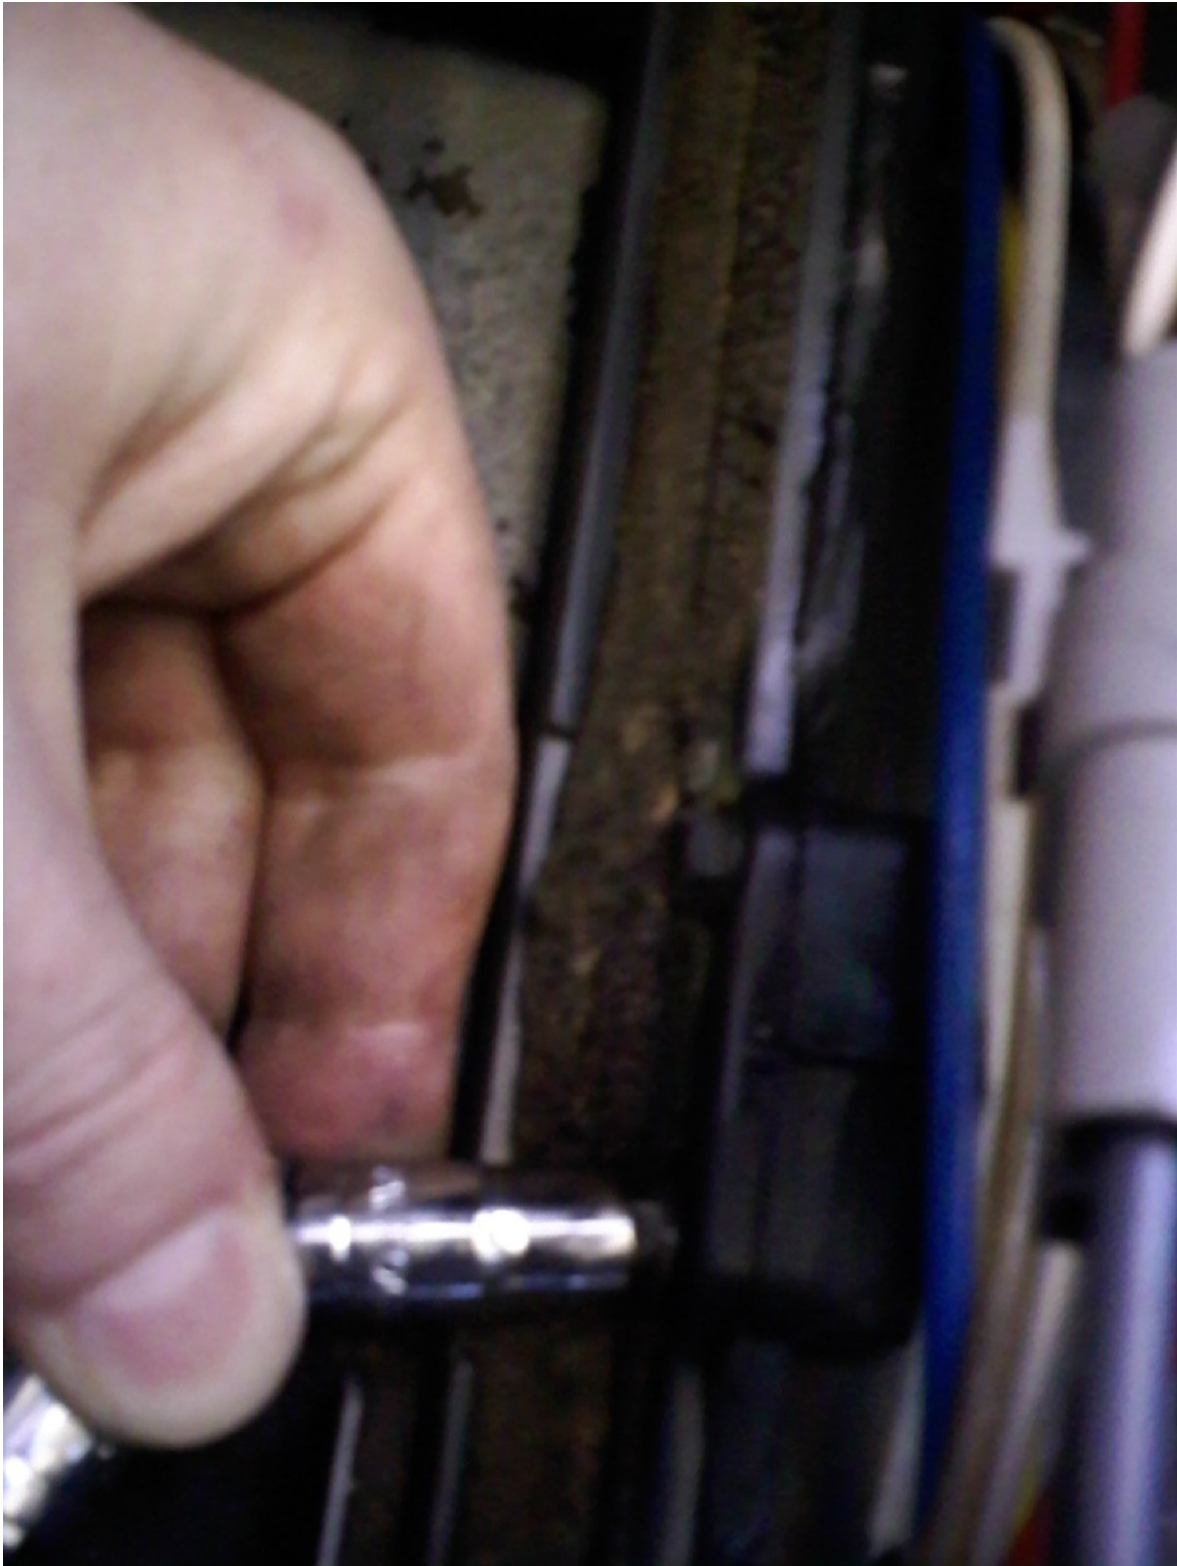
The FAQ describes the location of the screws. There is one buried up above the box, behind the foam ring on top, that is nearly impossible to get to. Don't get frustrated and break this off, or the whole box will likely bust in half. I was able to get it off with an extension and a universal joint after an hour of strain. However, I did not replace this one screw on reassembly.
