# Heater Core Replacement

## A Guidebook with Pictures

This guide was compiled while following the extensive manual at the Brickboard FAQ. While the manual is very good, this pictorial guide should serve as a helpful supplement for the brave people who undertake 700 series heater core replacement. Good luck to you all! It's actually not that scary.

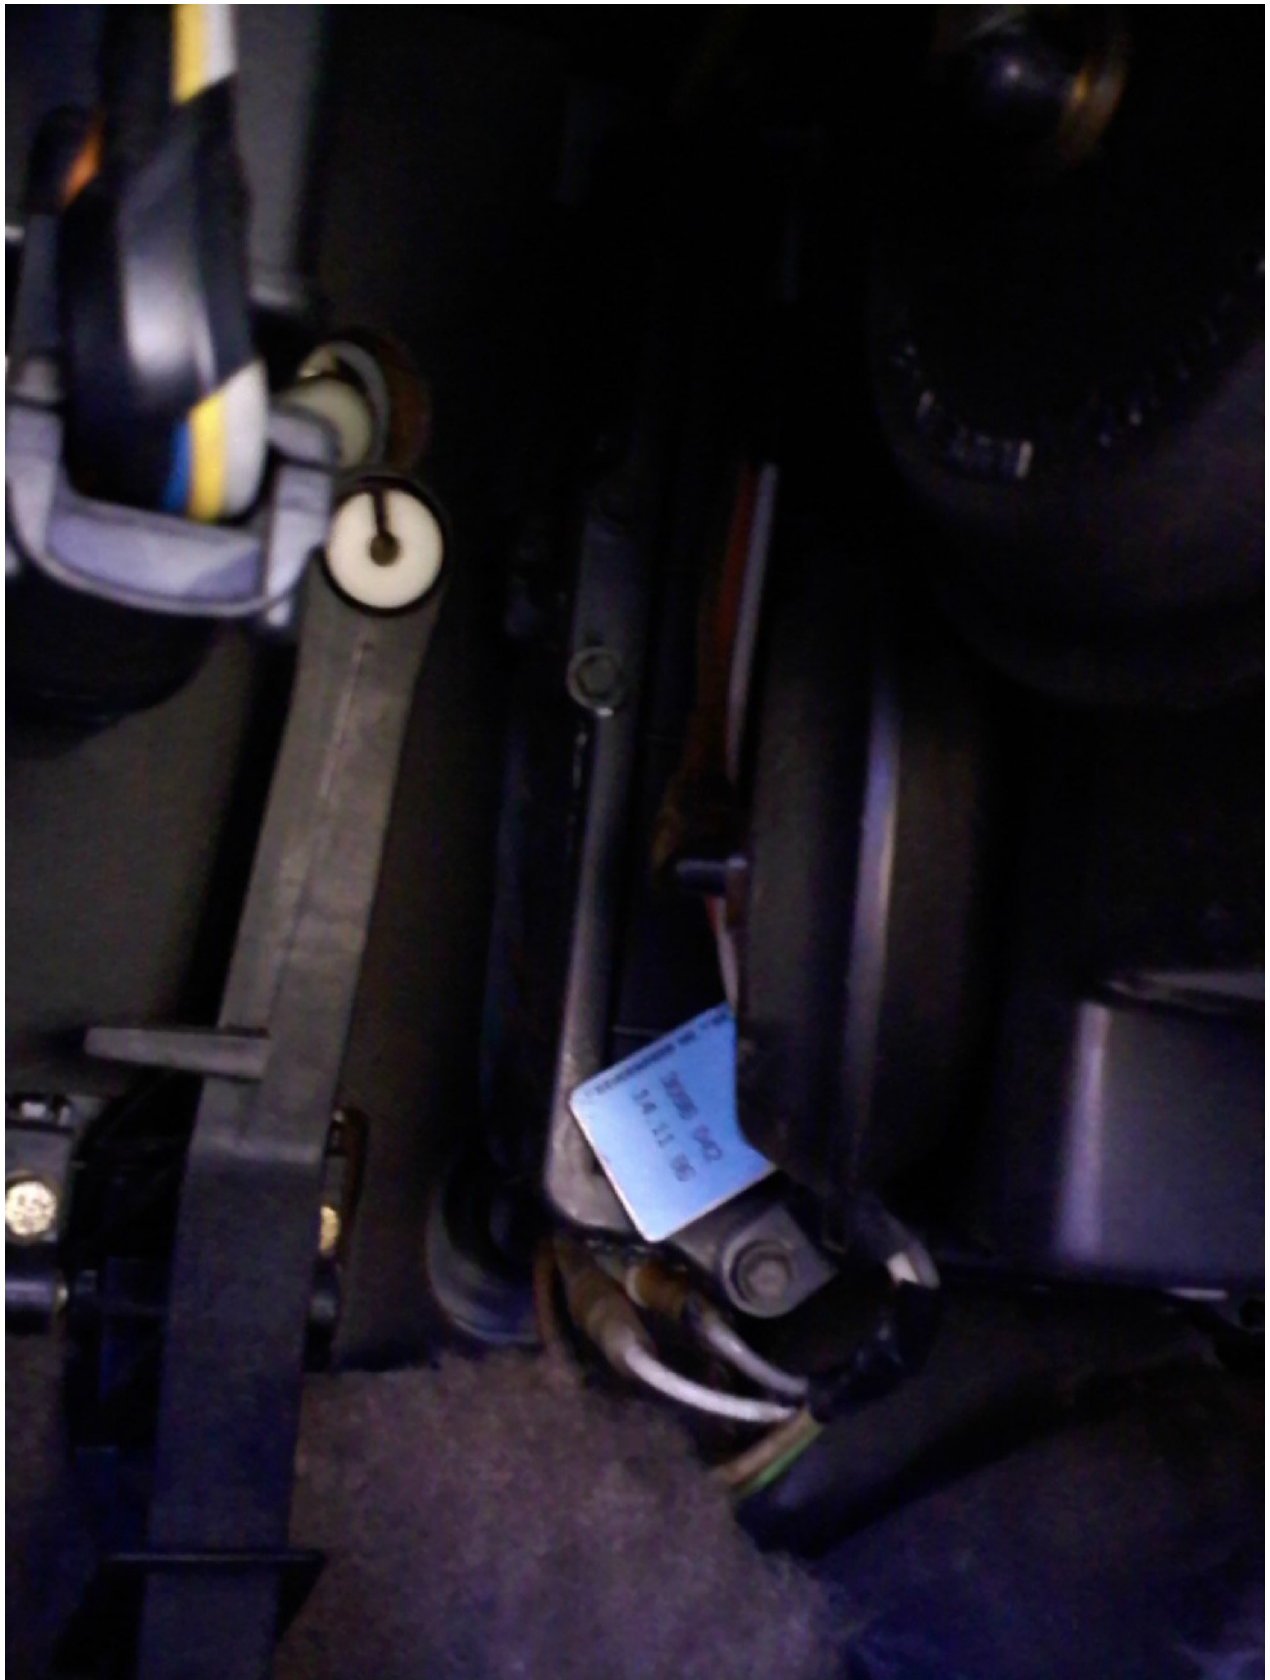
The vacuum hoses on the side have this funny slip-on yoke. Be careful, patient, and don't break it.

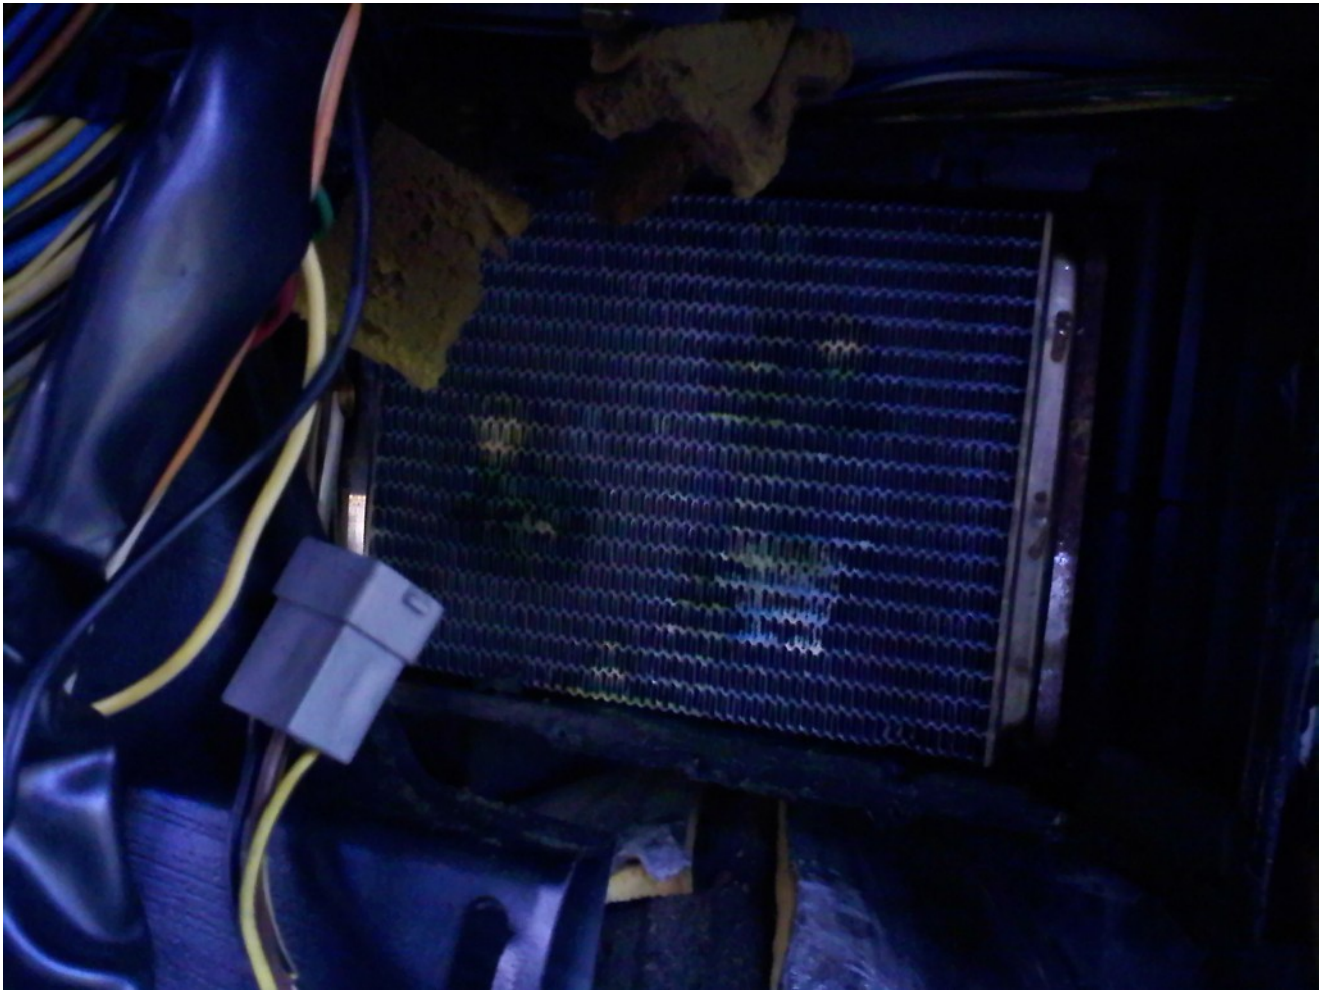
GROSS!

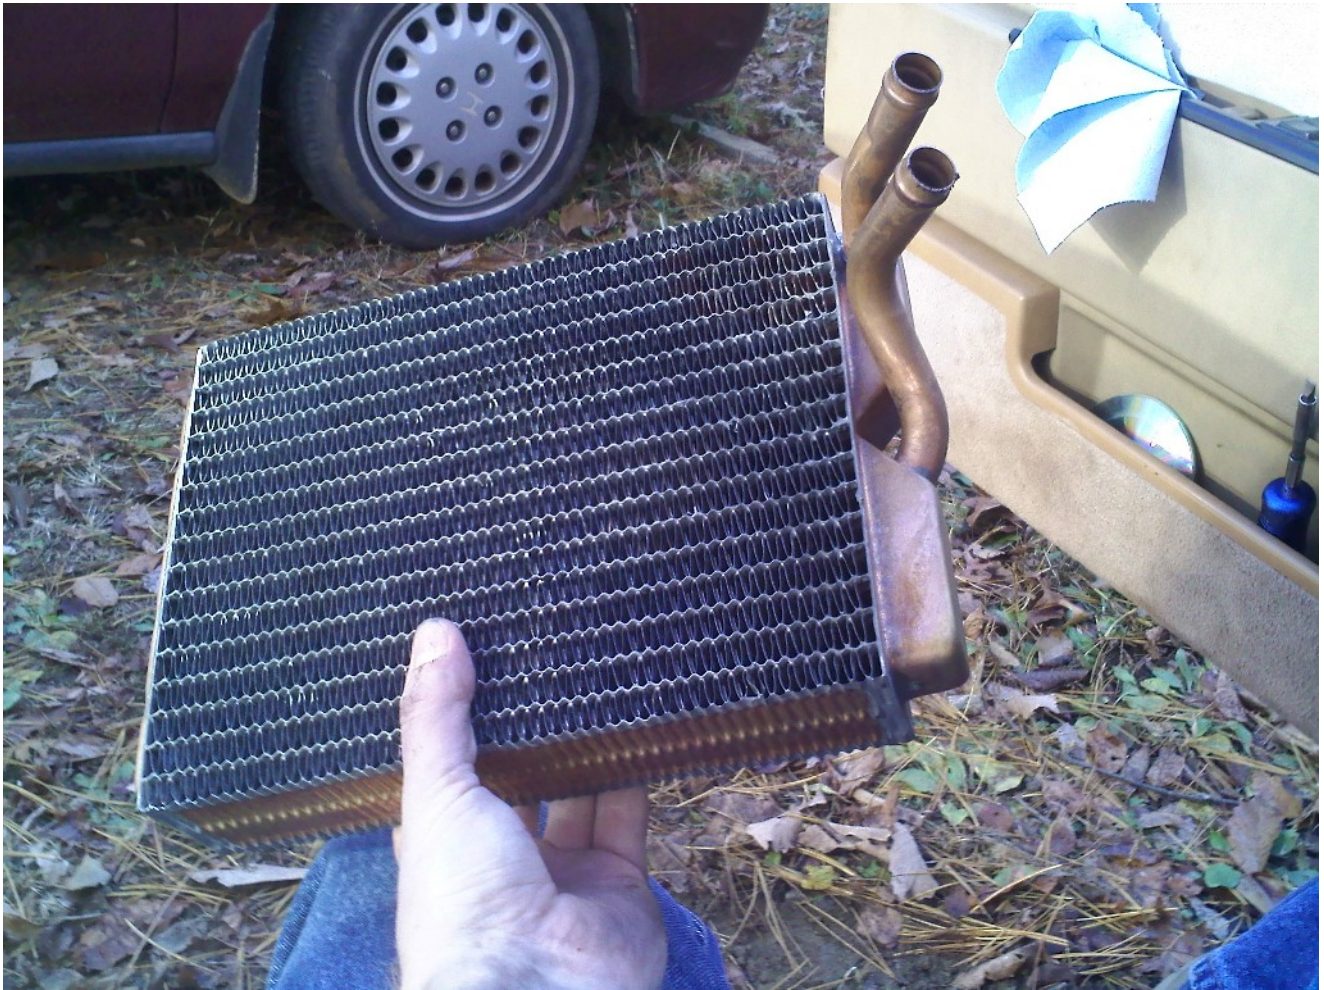
The new heater core was shiny. \$125 at Rock Auto, all metal. Fitment was a bit of an issue, though, and I had difficulty installing it with the straps in the proper place.

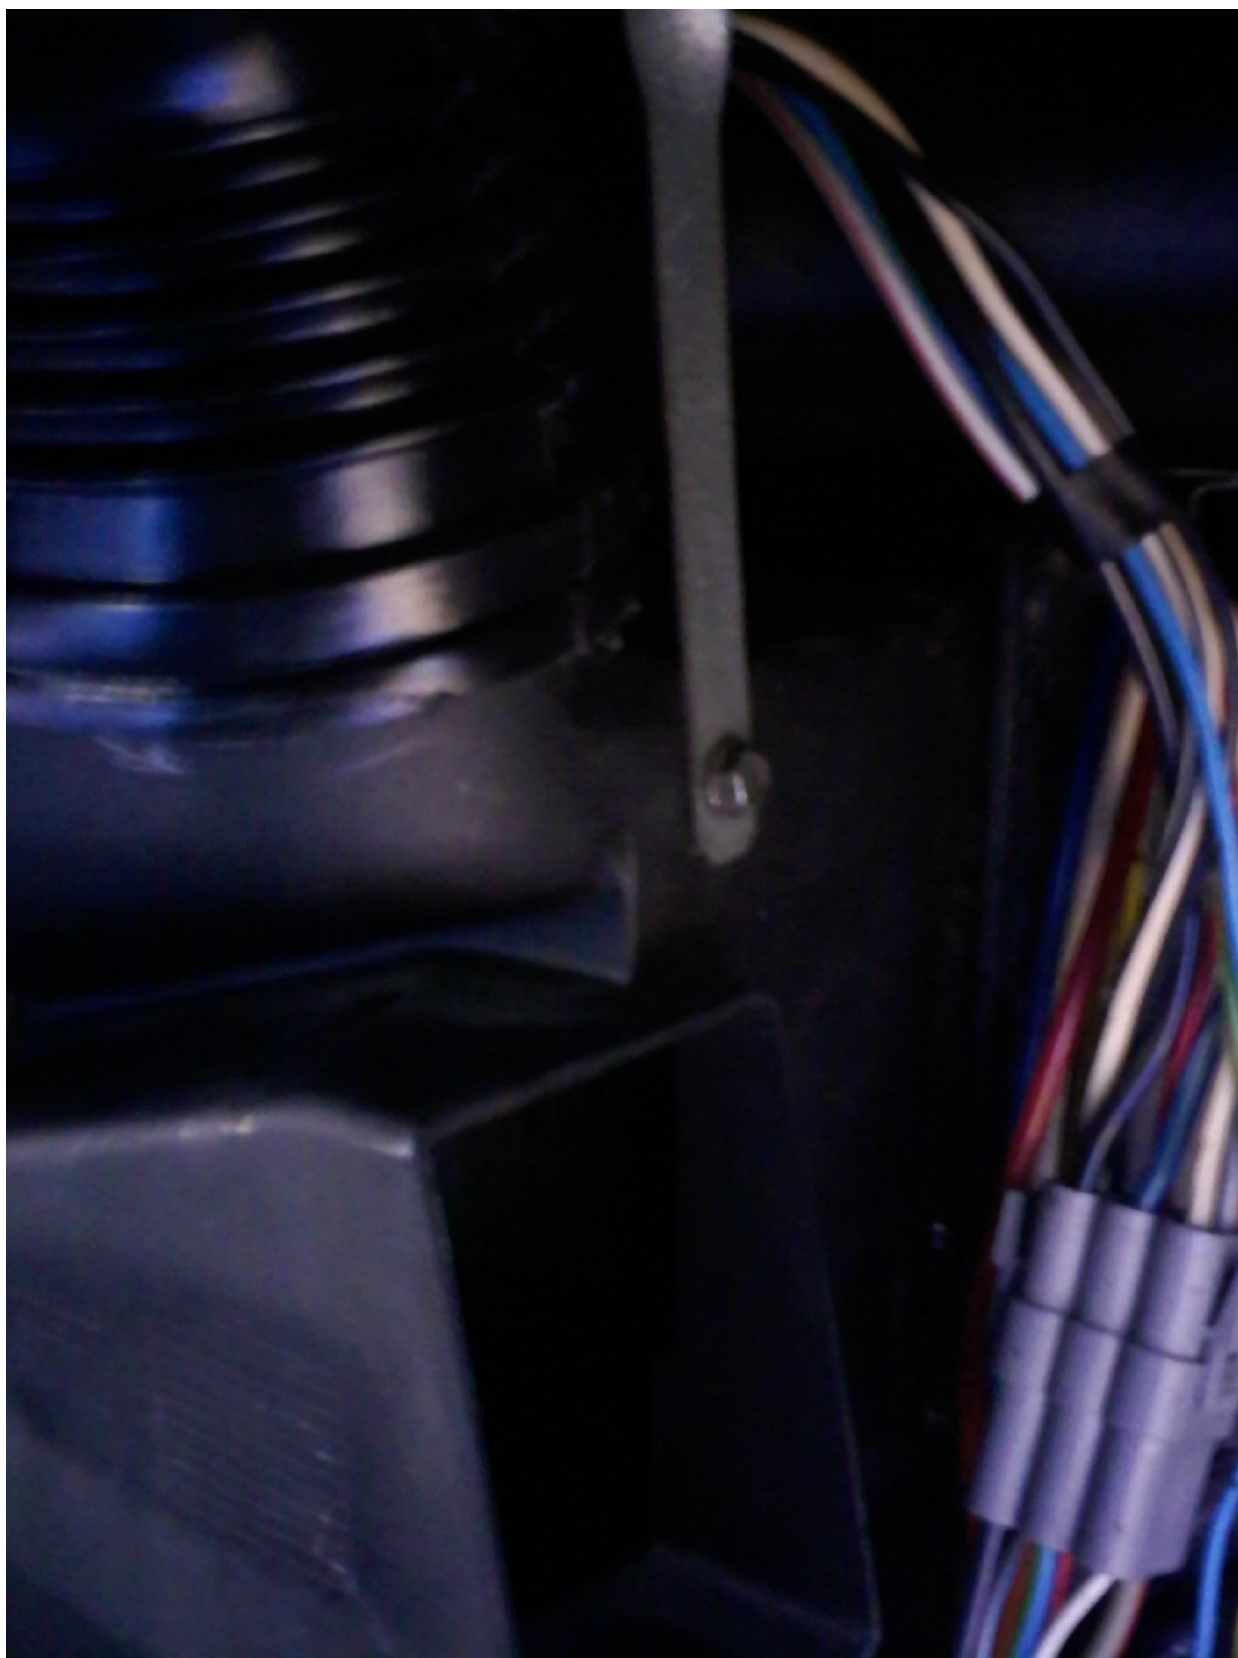
When the time came to put the metal strap back (essential to getting things stable and fit back together), I used a random screw I found.
