Roof, integrity check

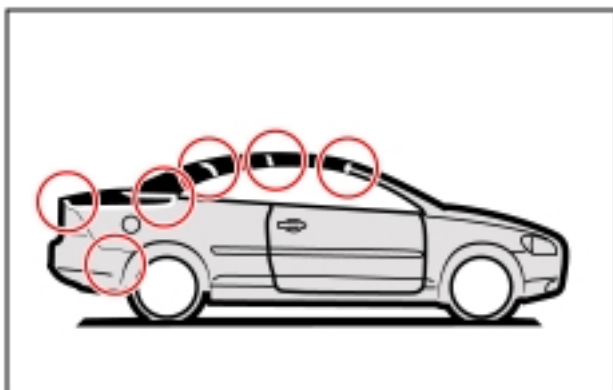
235730

Check extra carefully at the points indicated in the figure.

- 1 seal strips roof bow/A-pillars: VCC-264600-1, Weatherstrip, roof bow/A-posts, replacing
- 2 roof panel middle: VCC-265341-1, Center roof panel, replacing
- 3 trunk lid: VCC-264618-1, Trunk lid, adjusting
- 4 check installation of the bumper: VCC-264948-1, Bumper rear, replacing
- 5 seal strip luggage: VCC-264604-1, Cargo compartment weatherstrip, replacing
- 6 seal strip rear roof panel: VCC-264602-1, Weatherstrip, rear roof panel, replacing
- 7 side windows: VCC-264620-1, Rear power window, adjusting and VCC-264621-1, Front side power window, adjusting.

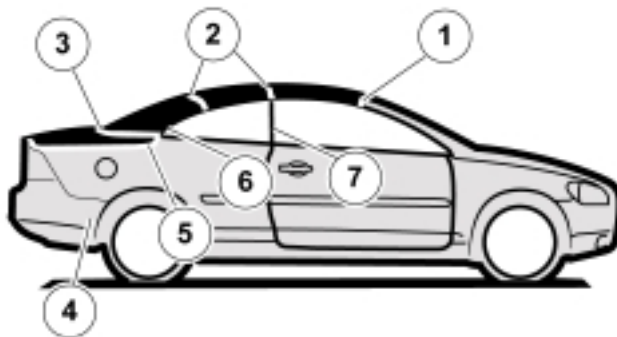
235734

In case of leakage at indicated positions in the figure, see:
