Service Bulletin.

THERMOSTAT HOUSING

(Coolant thermometer)

B 16 Engine

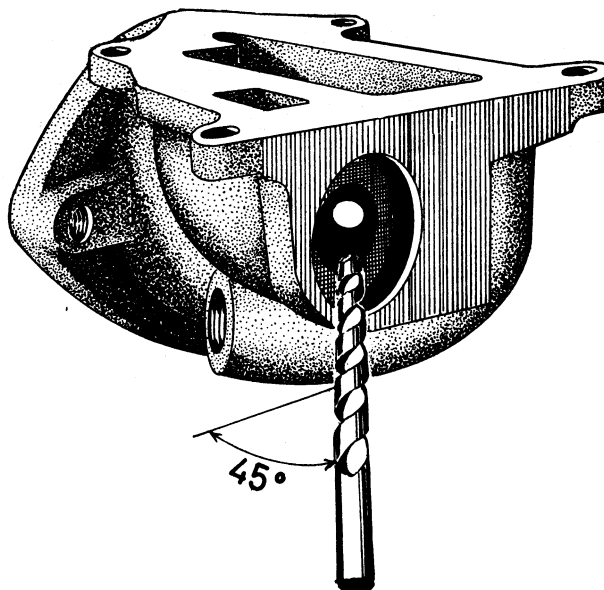
The diameter of the hole should be 6 mm and its position is shown in the diagram. First mark the position of the hole with a centre punch and drill a pilot hole. Take care that the facing surfaces do not get damaged.

If, however, any customers should be dissatisfied with this, it is possible easily to avoid this inconvenience by drilling a hole in the wall of the thermostat housing. The water circulation around the thermostat bellows is thereby increased so that more precise control is obtained.
