Volvo Plastic Fuel Tank Repair

Emergency Plastic Fuel Tank Repair

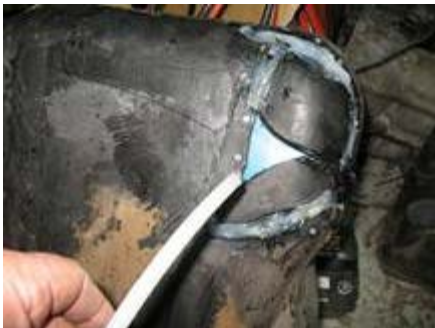
Before touching your tank, BE SAFE ! Make certain that the gas tank is empty before removing it from the car, and fill it with water before starting any heat related project on or around the gas tank, either in or out of the vehicle.

Plastic welding is generally done with either a controlled hot air stream with temperatures around 500 degrees F or with an electric iron device that works in the same manner as a solder gun. Both are fairly expensive at around \$120.00 to over \$200.00 for the commercially available models. Welding rod is also a necessity and can be obtained from most plastics suppliers. For our purpose, this being a polypropylene tank, I am using poly tubing from Home Depot

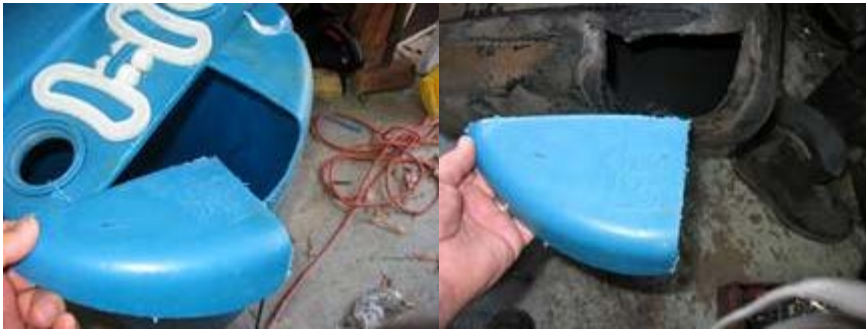
Since I have big holes to fill, a blue polypropylene drum is a suitable candidate for patching material.

The actual welding is very similar to welding with a torch (brazing) or TIG welding with a fill rod. The hot air is directed at the surface of the plastic in a small circular motion until the plastic starts to look wet. With polypropylene this is around 375 to 400 degrees F. The fill material is then fed into the hot air stream and flowed into the area to be welded together. If you are using white poly airline tubing, it will change from opaque to clear just as it melts.
