## **Transmission:Automatic**

### **[Volvo Maintenance FAQ for 7xx/9xx/90 Cars](#)**

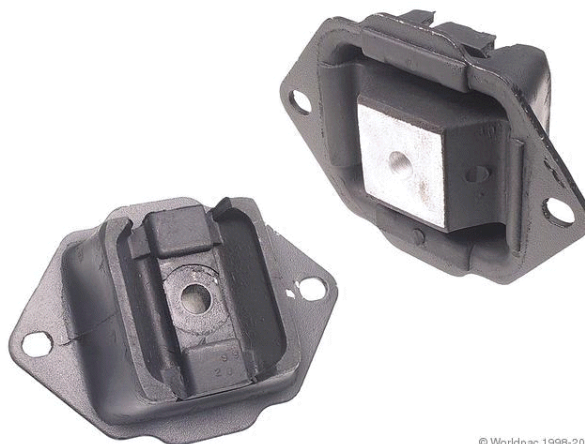
[Editor] The rubber transmission mount will compress over time and need replacement. To do this, support the front of the car on jackstands. Place a jack under the transmission pan with a board to distribute force and jack up enough to support the transmission. Remove the rear support cross member and change the transmission mount, reinstalling in reverse order. *Welded Frame Nut Breaks Off.* If one of the frame nuts breaks off, see this [link](#) for a repair using a serrated flange nut.

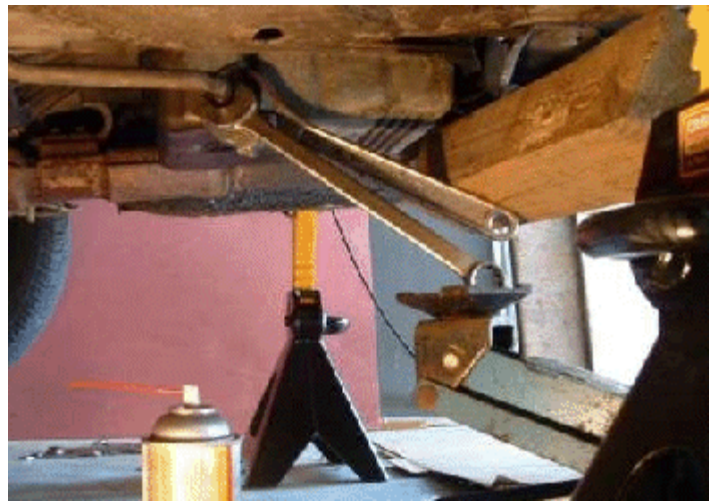
- Use plenty of PBlaster all over the nut and let it soak for a day.
- Use a quality open-end wrench and adjustable wrench as backup. No Chinese tools here. Under no circumstances should you **not** use a backup wrench, as you will tear the transmission pan. [Tip from Glen] You need to hold the big nut steady and try to turn the smaller nut. The big nut is actually not a nut at all: it is a threaded flange with hex sides. It does not turn. If it turns, you have ruined the pan. I place a

relatively large crescent wrench (open end adjustable wrench) on the filler tube flange nut, with the end of the wrench pointed toward the rear of the car. If you orient the wrench jaws correctly, you

can brace its handle on the flange of the transmission pan (the flange where the gasket is located). It's a tight fit, but it works. I then use a smaller crescent wrench to turn the small nut ccw. The first wrench prevents excessive torque from being applied to the filler tube flange where it enters pan. I sometimes need to use a breaker bar (steel pipe with one end flattened to fit over the wrench handle) with the small wrench to generate some extra torque.

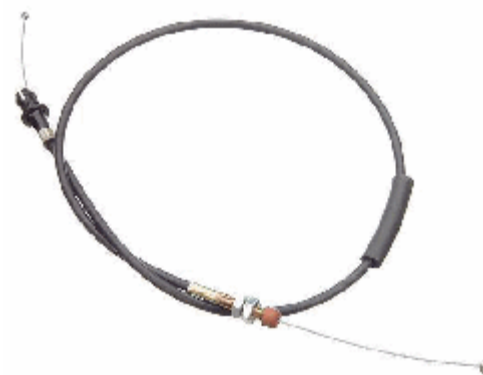
**Repair Procedure.** [Tips from various and Nelson Torres] Parts are about \$100 - \$75 for the kickdown cable, \$25 for tranny pan gasket and filter. It's about an 1-1/2 hour job, very messy though as you must drop the tranny pan. You kind of need an assistant to help with the cable, and a long pair of narrow vise-grip pliers. Basically :

- Drain the transmission of fluid.
- Unbolt the dipstick/filler tube from the transmission sump (requires 24mm wrench and 30mm counterhold wrench; may be [very difficult](#) and require a giant pipe wrench). More fluid will run out. Placing a box with a plastic liner and filled with kitty litter under the tranny will minimize the mess.

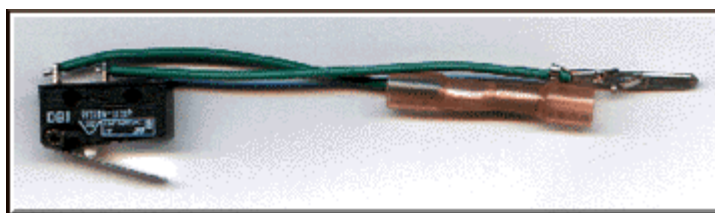
[Response: Bob] Shift lock solenoid not releasing. Possible causes, brake light switch, micro switch in shifter assembly, or bad solenoid. Micro switch most common. Access the shifter by removing console; on the passenger side near indicator is a small black switch with a metal lever. The switch is about 1 in. long @1/2 in wide, mounted with a small round metal clip. There are two black wires. You have to unbolt the shifter and lift up slightly to access switch, but don't have to disconnect anything under car. Be careful removing switch retainer as its easy to break the small plastic post the switch mounts to. To test, short the two wires together with key on and brake pedal pressed. If it now comes out of park, replace or bypass the switch.

**Repair Notes.** [Editor] This is a known frequent-failure item, in part because the ridiculous design of the switch mounts on two small plastic pins with push fasteners to hold it on. The switch itself does not last long. If you replace yours, install the new one in such a way that a replacement can be easily installed.

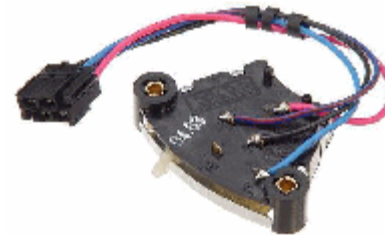
[Response: Rob Bareiss] Your neutral safety switch is the trapezoidal switch beneath the shift indicator plate on the right.

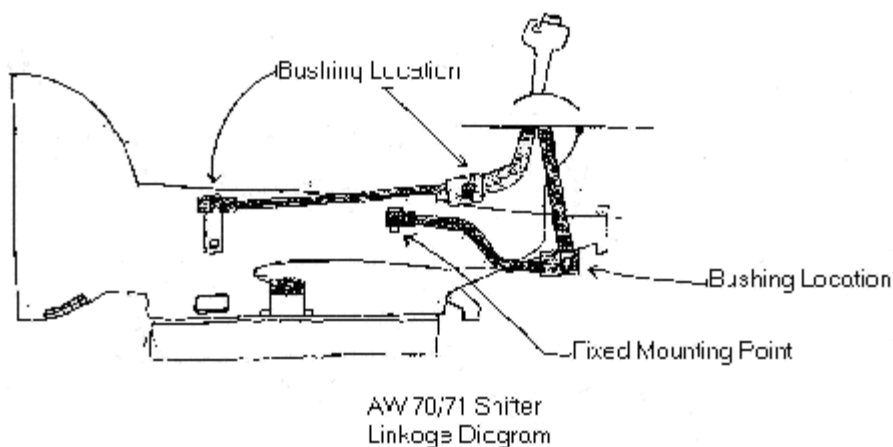
1. **Replacing Rubber Shifter Bushings.** The illustration shows how the shifter mechanism is arranged and where the three donut shaped bushings are located. Mark the linkage pin position with a chisel so you can replace the shifter linkage without having to re-adjust it.

Once the bushings have been located on the car, remove the C-clip that holds the linkage rod on the pin or arm. This C-clip is often rusted. Take the pin off the rod, remove old bushing, install the new bushing and replace the C-clip, making sure you drive it home so it does not fall out. Be sure not to lose the clips that hold the linkage together and don't take the whole thing down - do one end at a time and save your self the grief of not being able to remember which way it went. With normal use, these bushings will need to be replaced every five to eight years to maintain the new feel of the shifter. The bushings are a little easier to get in their holes if you let them soak in some very hot water first, this makes them a little more flexible. Push into the holes with a screwdriver once you get one side started. Spray them with silicone for better installation and lubrication afterwards. Tips: the rear linkages require a 15mm backup wrench; since access is tight, a narrow bicycle wrench helps. The front pin is often rusted in place. Use plenty of penetrating oil and try to lever it out with a wide screwdriver. Once you have it slightly out, use Vicegrips on the wide end to rotate it free.

2. **Tightening Shifter Linkage Rod.** As the illustration indicates there are two places where shifter linkage rods attach to the transmission. One attachment place is the movable gear selector lever. The other connection point is where the short, double bent shifter rod attached to the longest lever from the shifter connects to a fixed spot on the transmission body. To correct any looseness here a bushing must be placed around the clevis pins that secure the linkage rod to the transmission housing. I fashioned a bushing from a very short length of clear vinyl hose with a 1¼ ID and 9¼ OD. I do not know what kind of bushing was installed at the factory since it was completely missing where I made this repair to my car. The vinyl tubing, however, does an excellent job eliminating slack and preventing any rattles. Now is a good time to inspect the overdrive wire as well, since insulation can wear in this exposed location.

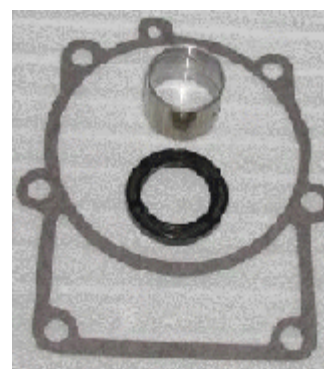
[Note from Abe Crombie] The 93 through '95 model AW71 gearbox has a ball bearing instead of the earlier bushing. You can tell by looking at the output flange where driveshaft attaches. The bushing style has no bell shaped slinger/protector for the seal; the bearing type has this type flange. The slinger/protector prevents you from seeing the seal. The standard flange on the bushing versions allows you to see seal on tailhousing. The bearing can't be used in place

of the bushing as it requires a different output shaft in rear of trans; and it is costly. This style has an oil seal at the rear of the housing and an o-ring inside. Repair is simple: just pull the housing off and replace both the seal and the o-ring.

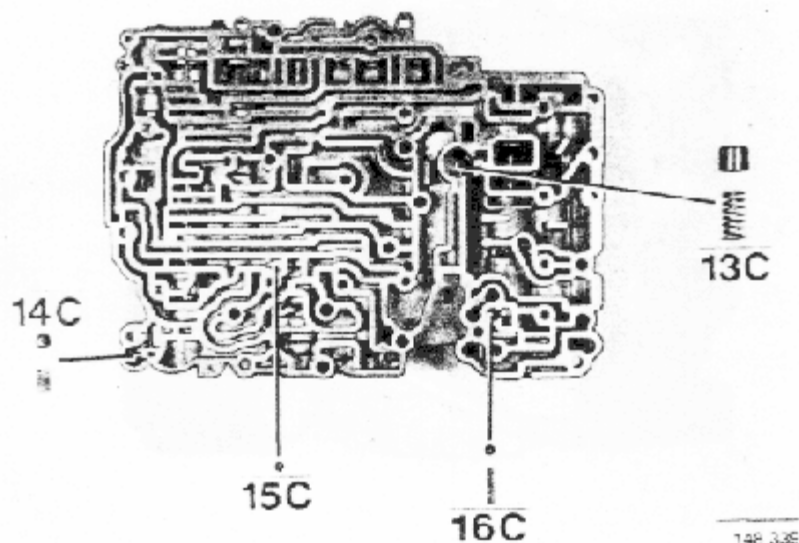
**Worn Valve Ball.** [Toni Arte] The real cause for this problem is a worn valve ball in the transmission valve body. This ball is the 15C in the picture. This is a picture of the lower valve body. A replacement valve ball is available, you can order it from your local Volvo dealer. The part number is 1377746-1 (small blue valve ball). [Tip from Herman] You may need gasket kit p/n 271292. Before you do the job, buy the OEM manual: the manual number is TP 31642/1. The manual is for AW70/70L, AW71/71L, and AW72L. The L means lockup, check the tag on the tranny before you buy your gasket kit. For detailed instructions, see Brad Wightman's excellent [illustrated writeup](#).

In my case the 5.5 mm valve ball was worn to about 2 mm size. Note that the valve body can be accessed through the oil pan, so it's not necessary to drop the transmission. A competent transmission shop should be able to change this ball. In my case the cost was about \$100, this includes two hours of labour, new gaskets and fluid.

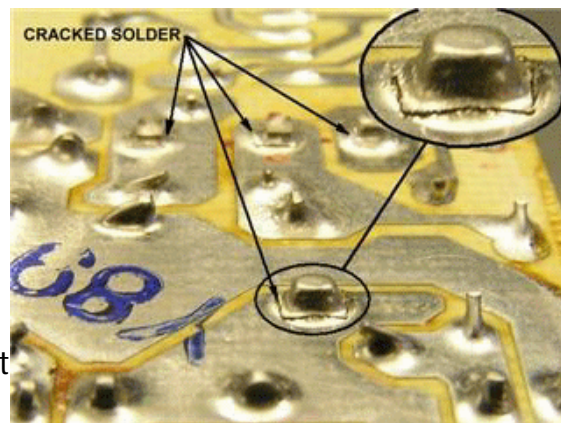
[David Brewster] Wave solder joints can crack and cause relay failure, as shown in the photo. These can be easily repaired with a soldering iron. For a more detailed discussion of relay repair, see [Relay Repair vs. Replacement](#).

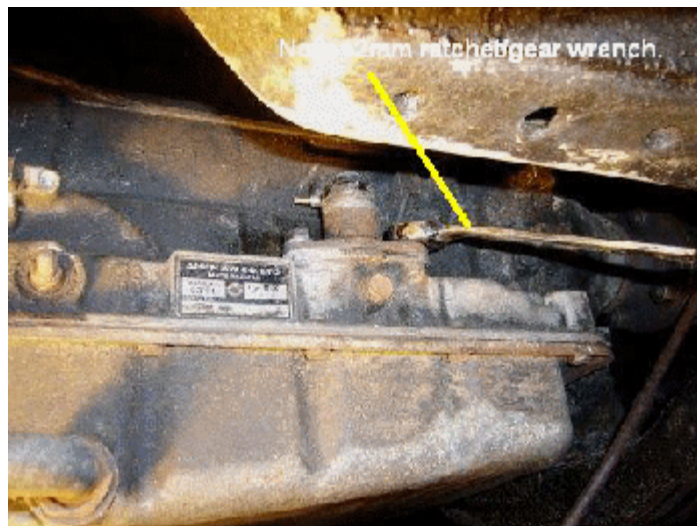
[Ryan Ridgely/R Haire/SML] Wear eye protection. For ease of removal, GearWrench brand ratcheting box wrenches with the flexible head work well and do not force you to drop the transmission. Support the transmission with a jack and remove the cross member (although one user did the job

whilst lying on the right side of the car and reaching underneath). Then lower the trans about an inch to give you enough room to CLEAN the area around the solenoid until it is spotless before ever attempting to remove it. Do NOT lower it so much you crush the distributor cap against the firewall. To remove the solenoid, you need a stubby angled 12 mm wrench. The rear bolt is the more difficult of the two. It is snug up in there and you do not have much range of motion. A "gear wrench" is ideal to turn the bolt. Be prepared for a lot of oil to run out: about a quart/liter. [Tip] I have used a short (approx. 6") angled/bent 12mm open end wrench that I heated and bent myself. Access is difficult: you may have to remove the linkage and drop the transmission support (placing a jack and large wood plate beneath the pan to support the tranny). [Tip] Bend a flex socket handle to fit and use a 12mm socket on the end to remove the solenoid bolts. [Tip] Use a smaller 1/4 inch drive socket set to remove it. Note that there are two o-rings to pull out.

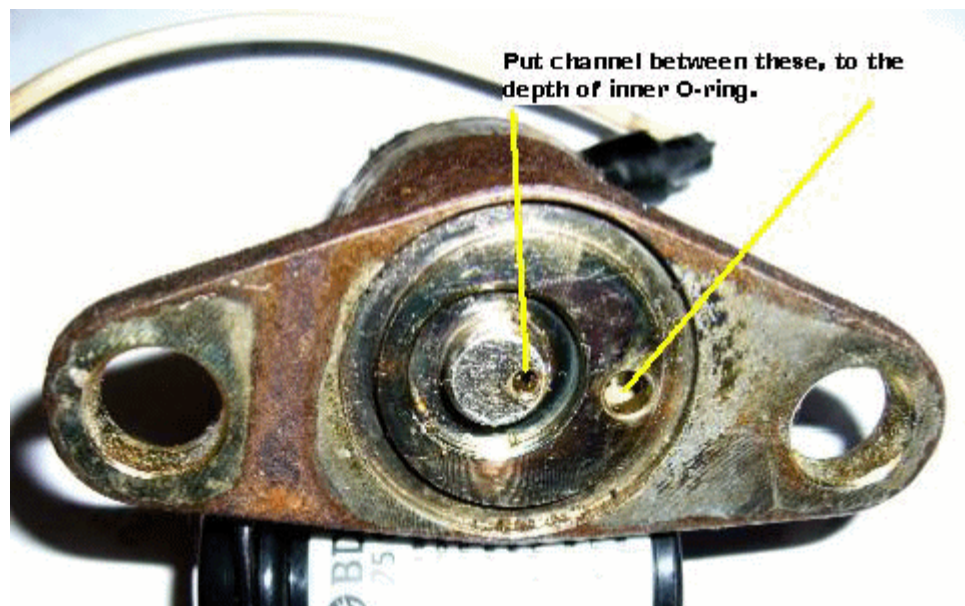
You can also pull the solenoid entirely, replacing it with a metal plate, and remove the ability to use the button to manually shift down into third. See the [link](#) below for IPD's solution to solenoid troubles.

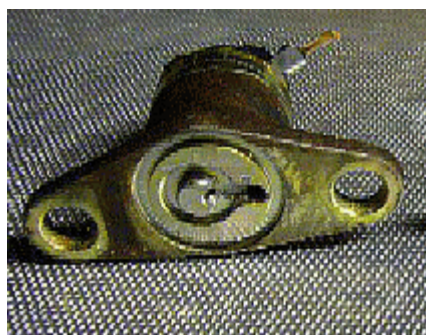
[E. J. Ohler] Forget about a new \$150 solenoid and \$50 relay: take the solenoid out, cut the wire off and cap the end, grind a small groove between the center hole and aft hole in the solenoid face, and reinstall to allow fluid to move and disable the solenoid as a solution to solenoid troubles. Use a Dremel 1/8 inch grinding tool (the metal is hard so you will use two) or a diamond bit. Clean the matching holes in the tranny using drill bits the same diameter, but don't drop them into the transmission. Replace the outer O-ring but not the inner where the groove passes through. From start to finish this is a 3 hour job that saves you a lot of headaches. You don't need the manual 4-3 downshift in most instances anyway.
