VOLVO

Group 278 No. A100

Service Bulletin.

A I R F I L T E R S

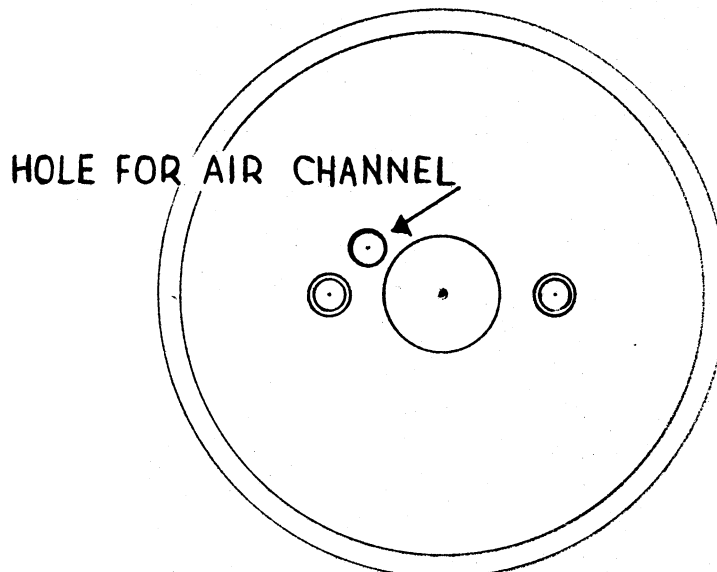
A I R F I L T E R

When both the air filters have been removed from the carburetters and are to be re-fitted, make sure that the gaskets and the air filters are fitted correctly. In each carburetter there is an air channel through which air from the filter is taken to the suction chamber unit on the carburetter. There is not so much risk of the gaskets being incorrectly fitted since they have the same profile as the surface of the carburetter housing. In order to ensure that the air filters are correctly fitted, check that the hole in the filter indexes with the hole in the carburetter. See the illustration below.
